**Assembly and Detailed Testing Instruction**

- Dialog+ SW 9.xx

- **Level Regulation Option: Tubing Connection between Level Regulation Pump and Level Regulation Valve Block**

FSI\_2014\_4.1\_DialogP\_SW 9xx\_Level Regulation Module\_EN.doc/pdf Rev.: 1.01.00/2015 November

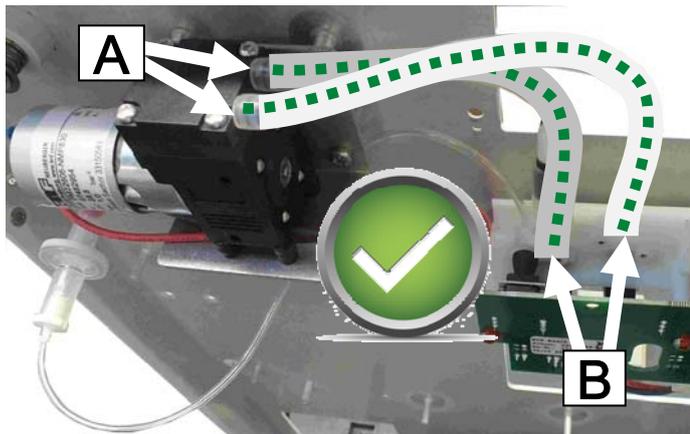
Fig.: Correct connection **A/B**

The correct connection of the tubings **A/B** shall be ensured after assembly by a visual check and a functional check.

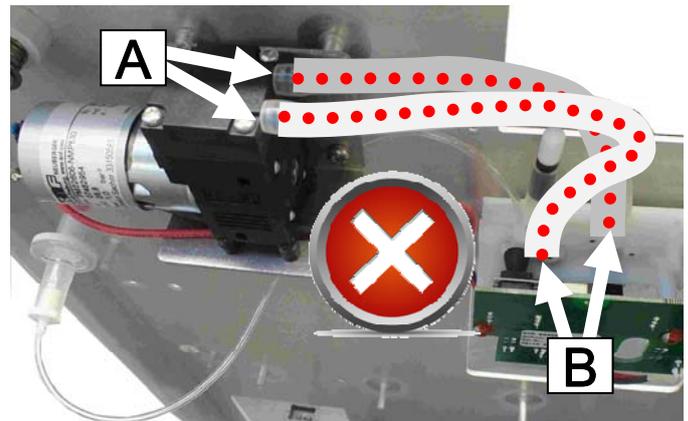
It is technically possible to incorrectly connect both tubings at the level regulation pump **A** or at the level regulation valve block **B**. This can occur during service, e.g. exchange of a defective part, disassembly for better access during a service activity.

These incorrect connections of the tubings **A/B** will cause a malfunction of the level regulation system, which is not necessarily recognized by the user.

Fig.: Incorrect connection **B**

Connect a blood line system (normally used by the user) to the machine. All fluid levels in the connected chambers shall increase and decrease by activating the *Up* and *Down* icons in a simulated treatment. The machine shall be released for patient use only if the level regulation works correctly, i.e. the level in the connected chambers decrease when the *Down* icon is activated and increase when the *Up* icon is activated.
