TEST REPORT

Test Report No.: 912327-01/02 Issued: 28, 8, 2019

Name of product: LUMINAIRE - Streetlighting

Type of product: URBINO LED NEMA SOCKET

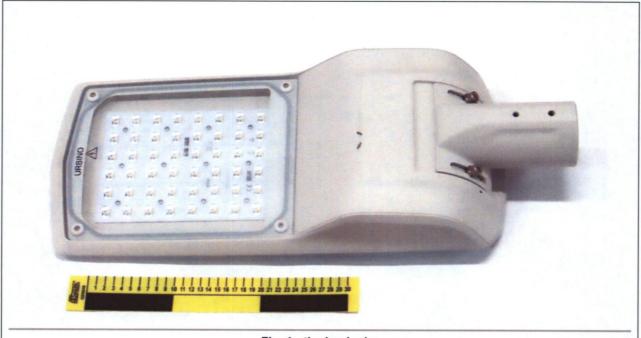
Fig. 1 - the luminaire

The luminaire is not equipped with drain holes.

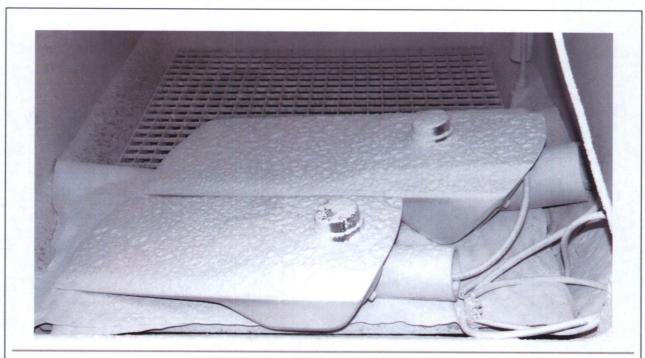
Fig. 3 - the luminaire after IP 6X test

During the test, no dust penetrated into the luminaire.

passed

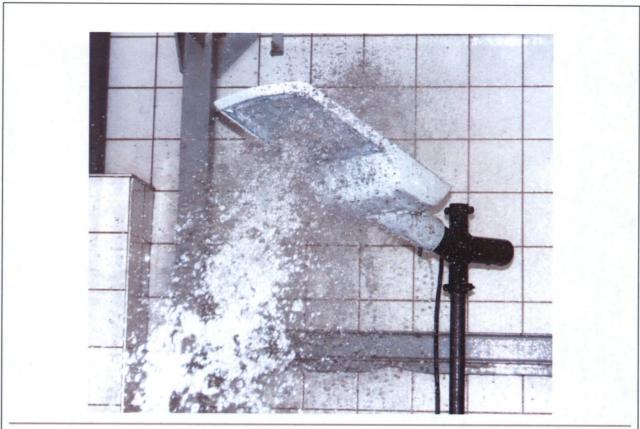
Fig. 4 - IP X6 test

During the test, no water penetrated into the luminaire.

passed
