Assembly and Detailed Testing Instruction

- **Level Regulation Option: Tubing Connection between Level Regulation Pump and Level Regulation Valve Block**

Dialog+ machines with software 9.xx and a level regulation option.

FSI_2014_4.1_DialogP_SW 9xx_Level Regulation Module_EN.doc/pdf Rev.: 1.01.00/2015 November

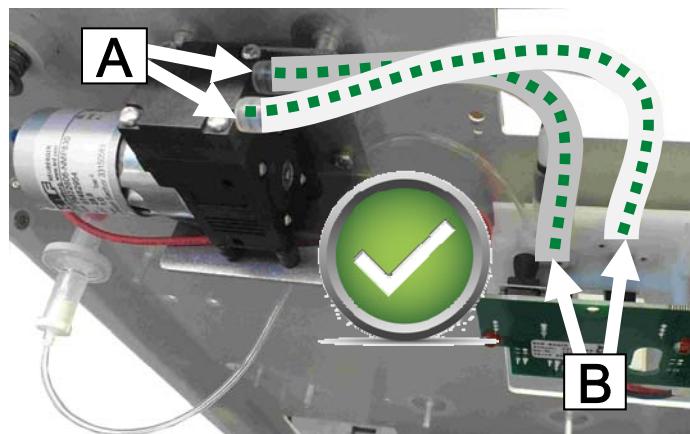
Fig.: Correct connection A/B

The correct connection of the tubings **A/B** shall be ensured after assembly by a visual check and a functional check.

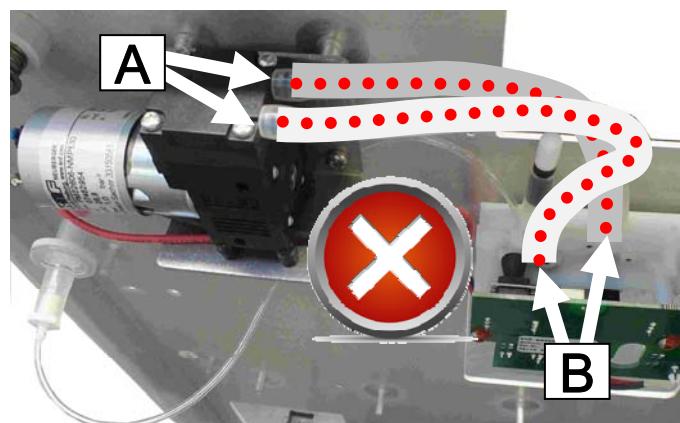
These incorrect connections of the tubings **A/B** will cause a malfunction of the level regulation system, which is not necessarily recognized by the user.

Fig.: Incorrect connection B

Hazard of air infusion via the arterial or venous patient connection due to an incorrect connected level regulation pump.

Connect a blood line system (normally used by the user) to the machine. All fluid levels in the connected chambers shall increase and decrease by activating the *Up* and *Down* icons in a simulated treatment. The machine shall be released for patient use only if the level regulation works correctly, i.e. the level in the connected chambers decrease when the *Down* icon is activated and increase when the *Up* icon is activated.
