# Your trailer has been hot-dip galvanised to ensure a long service life

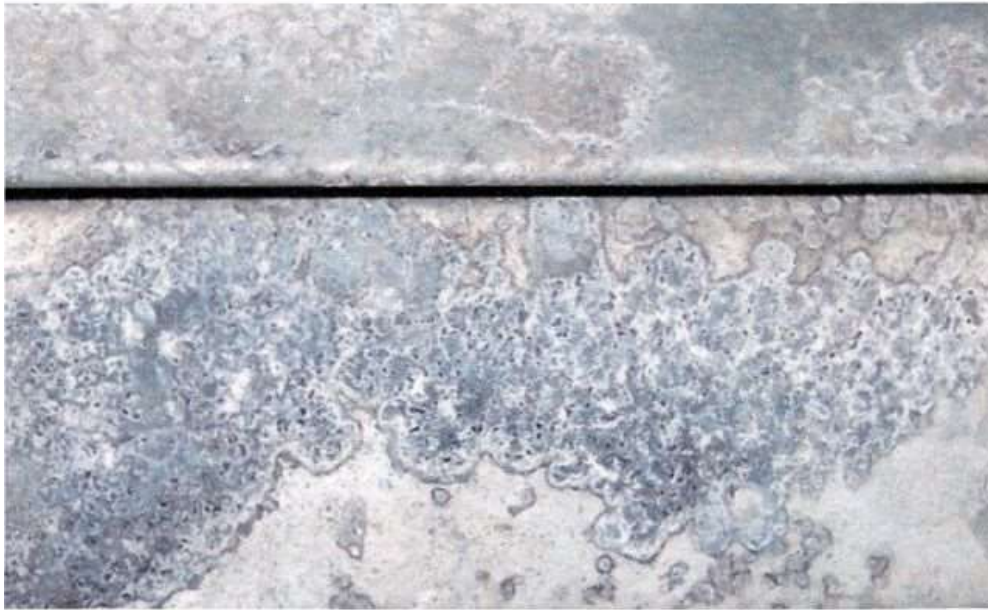
White corrosion is a clear, sometimes mealy, large-volume coating, which forms, when a newly galvanised product is exposed to condensation, moisture or liquid, which remains on the surface.

**Road salt** is aggressive towards most metals, including zinc. First of all, when the trailer is new and the zinc layer has not yet been completely passivated, the surface may be attacked, when the trailer runs on salt-sprinkled roads.

*The surface of the hot-dip galvanised trailer, where white corrosion has developed, when the trailer has been exposed to road salt.*

*Rinse the trailer after driving on salty roads. It is best to use warm water under high pressure. Rinse the trailer as soon as possible after being exposed to road salt.*

In order to remove the resulting white corrosion, rinse under high pressure, preferably with warm water, and then wipe with a sponge or cloth.
