# TYPE TEST REPORT

№ RSV9.3 6R 060/31.10.2017

The tested on-load tap-changer type RSV9.3-III-700-123/N-10.19.1W passed successfully the dielectric tests according to IEC 60214-1:2014 item 5.2.8 and program for tests of product №65/25.10.2017.

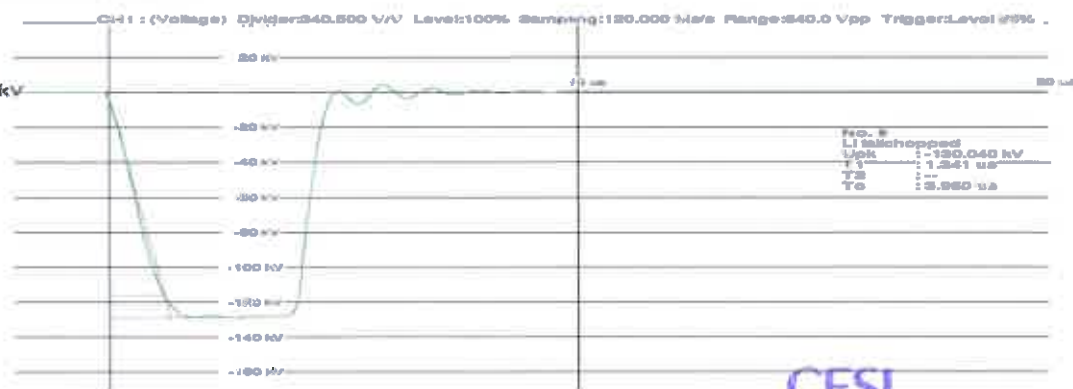
No. 8  
LI tailchopped  
Upk : -130.040 kV  
T1 : 1.341 us  
T2 : --  
Tc : 3.960 us

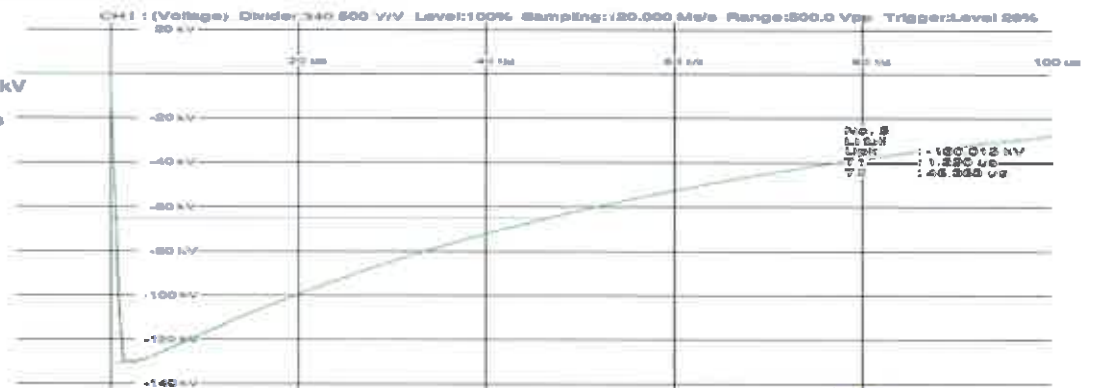
No. 5  
LI full  
Upk : -130.015 kV  
T1 : 1.320 us  
T2 : 48.368 us
