**Test report No. 1/29.08.23./IK-13****Test report for determination of degrees of protection provided by enclosure for electrical equipment against external mechanical impacts (IK code – impact protection)**

| Type of test object | LED luminaire | |
| Model and/or type reference | MRSTE 100 740 L05 AA016 NG1 (5mm printed glass with transparent logo with Zhaga) | |

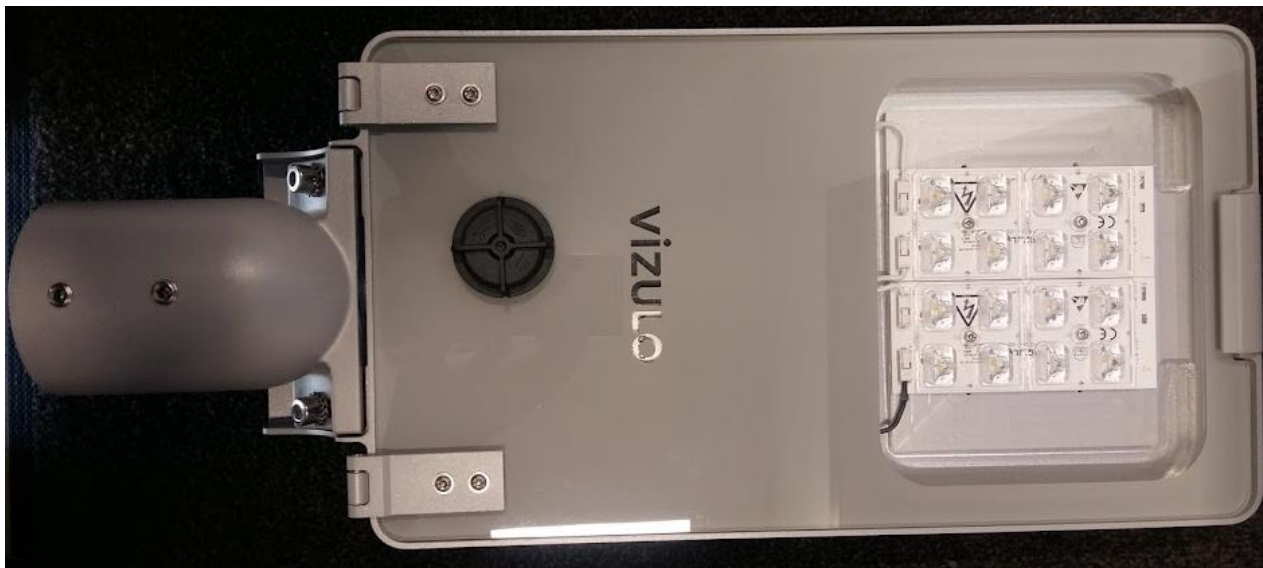
Photo No.1: test sample before testing

After testing and closer examination, the test object does not show any cracks or any other visual defect that might indicate its insecurity when used properly.
