# Test Report

Document No.	B6022563	Copy No.	1	Number of pages	24
Apparatus	Polymeric housing surge arresters				
Designation	PA-DM				
Serial Number	5401-5402-5403-5404				
Manufacturer	JSC "Polymer-Apparat"				
Client	JSC "Polymer-Apparat" 195427, Saint-Petersburg, Ak. Konstantinova Str.,1 - Russia Federation				
Tested for	-				
Date(s) of tests	October 21, 2016				
Tested by	CESI S.p.A. Via Rubattino, 54 20134 Milano – Italy				
Test performed	Short circuit tests

IEC 60099-4 (2014-06)

<b>Metal-oxide surge arrester</b>	
Manufacturer	Joint-Stock Company Polymer-Apparat
Type	PA-DM
Drawing	
Rated voltage (Ur)	54,0 kV
Maximum continuous operating voltage (Uc)	43,2 kV
Rated frequency	50/60 Hz
Nominal discharge current (8/20 $\mu$ s impulse shape)	5 kA
Arrester classification	DM
Rated short circuit current	
High current	for 0,20 s ; 20,0 kA
Low current	for 1,00 s ; 0,6 kA

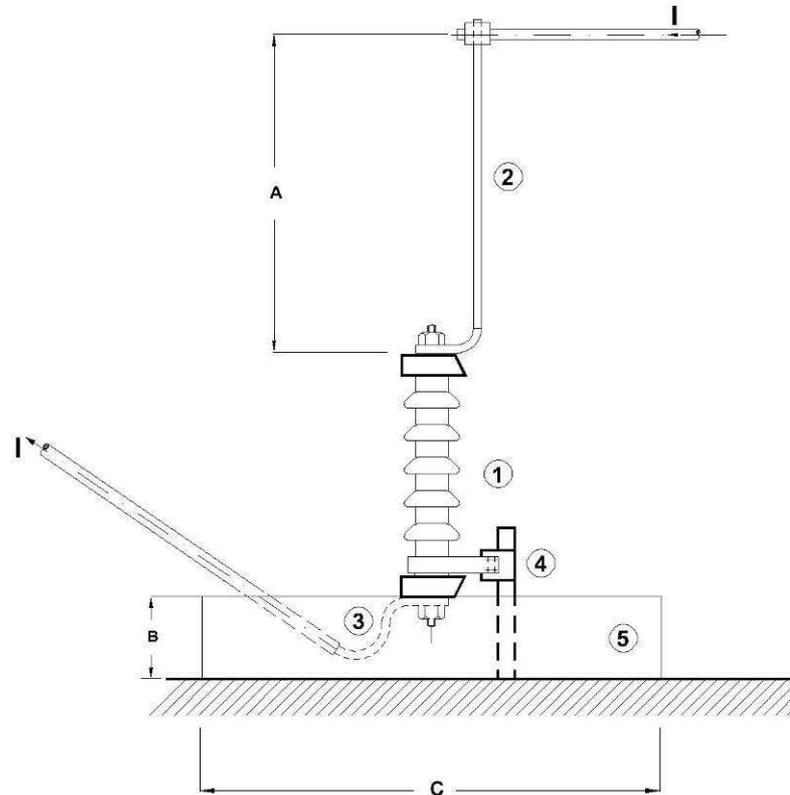
D8058 - Test arrangement

- 1 : Surge arrester
- 2 : Flexible conductor
- 3 : Flexible conductor
- 4 : Not metallic pole
- 5 : Enclosure

- A : 1,00 m
- B : 0,4 m
- C : 1,80 m

The arrester to be tested was installed by means of a crossarm on a not metallic pole at 0,4 m to ground in the middle of a square enclosure of 1,80 m in side.  
 The live side of the supply was connected to the upper end of the arrester while the return circuit, earthed, was connected to the lower end.  
 The live conductor was directed to the opposite direction as the earth conductor

**Test arrangement :** See D8058

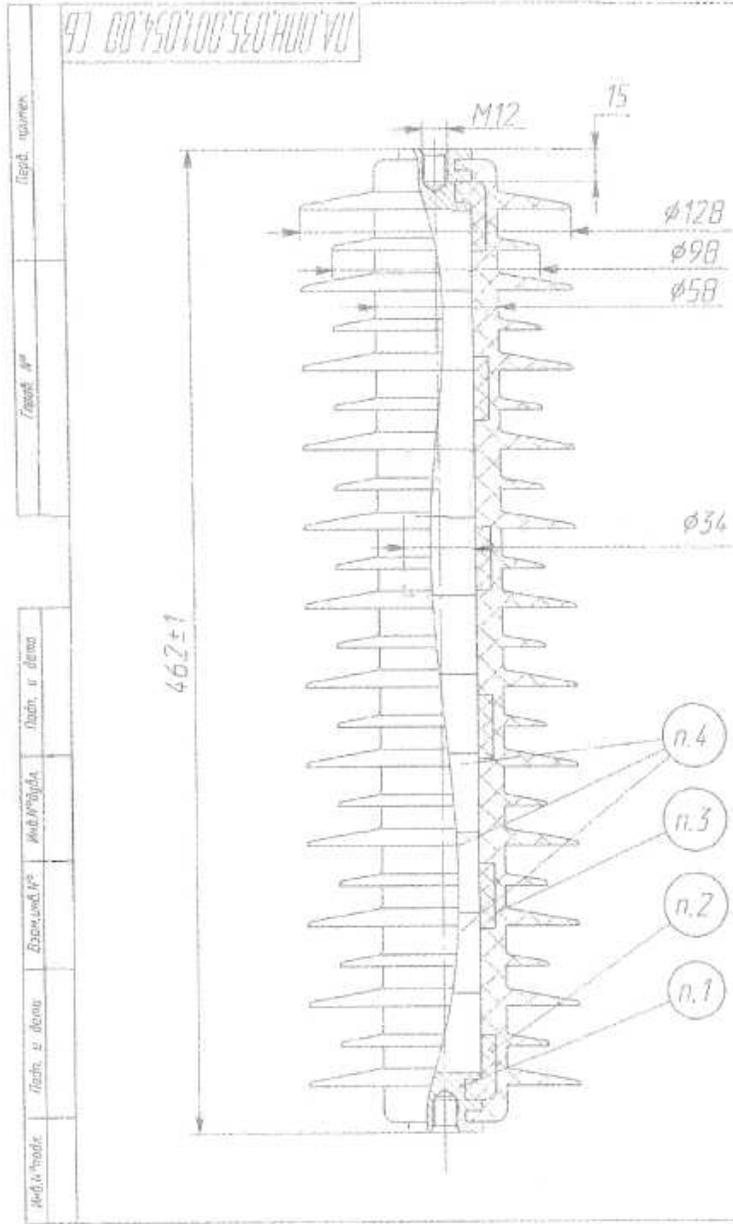
№ п.	Наименование/Name	№ черт./drawing №	Примечания/remark
1	Металлический фланец/Metal flange	ПА.ОПН.035.001.14 Д	
2	Изоляционный корпус/Insulations tube	ПА.ОПН.035.010.01 Д	
3	Защитная силиконовая оболочка/Silicone tuober	ПА.ОПН.035.010.03 Д	
4	Варистор/Metal-oxide varistor	-

The Manufacturer guarantees that the tested object is manufactured according to the submitted drawings. CESI checked that these drawings adequately represent in shape and dimensions the essential details and the parts of the tested object. These drawing identified by CESI and numbered B6019249 No. 1 are annexed to this document.

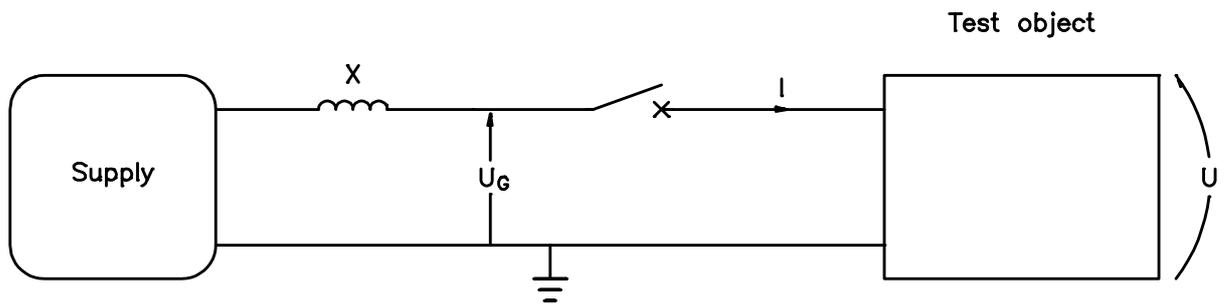
Test circuit D0046

Symbols used in this diagram are the same as those on the oscillograms.

**Test circuit :** See D0046      Power factor : <0,15      Frequency : 50 Hz

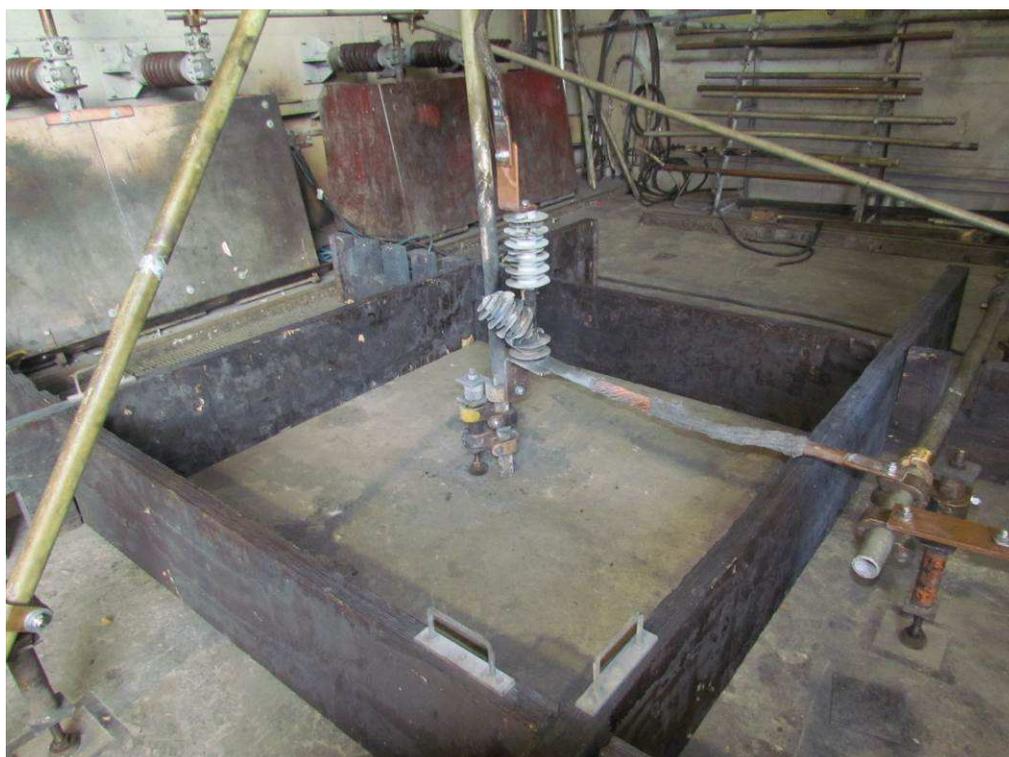
Photo No.2  
After the test No.1

- there was not violent shattering
- the arrester structure remained intact
- the arrester remained connected to the supply and return circuit
- no fragment were found inside or outside the enclosure
- the flame was extinguished by the operator after 6,0 seconds

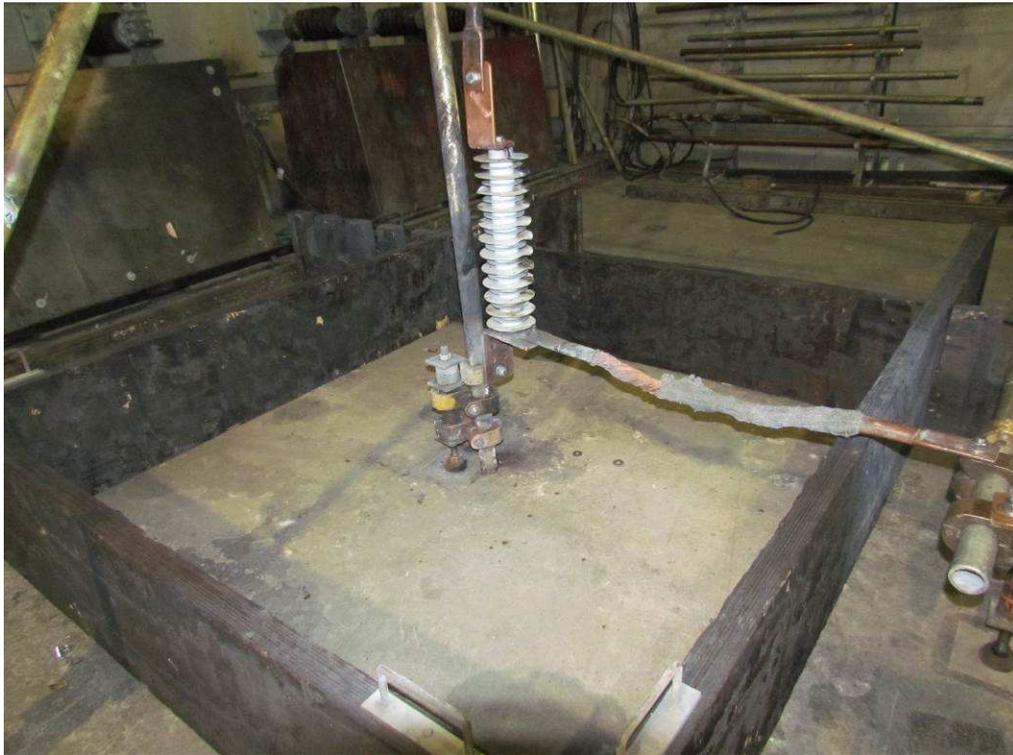
Photo No.4  
After test No. 2

- there was not violent shattering
- the arrester structure remained intact
- the arrester remained connected to the supply and return circuit
- no fragment were found inside or outside the enclosure
- no flame was noted

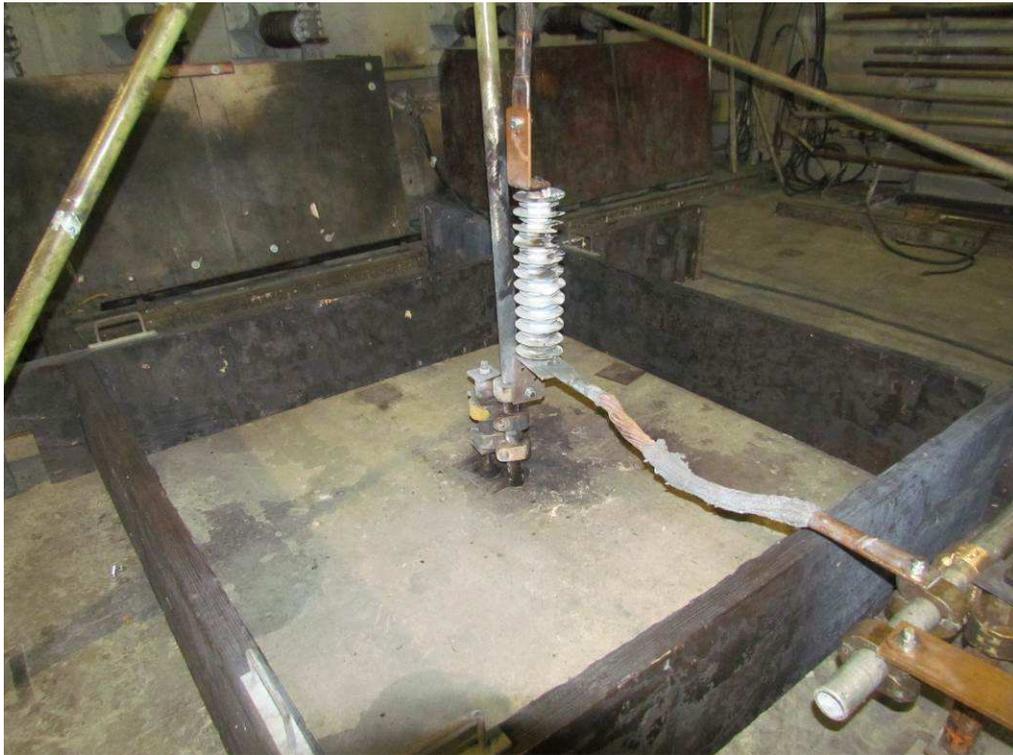
Photo No.6  
After the test No.3

- there was not violent shattering
- the arrester structure remained intact
- the arrester remained connected to the supply and return circuit
- no fragment were found inside or outside the enclosure
- no flame was noted

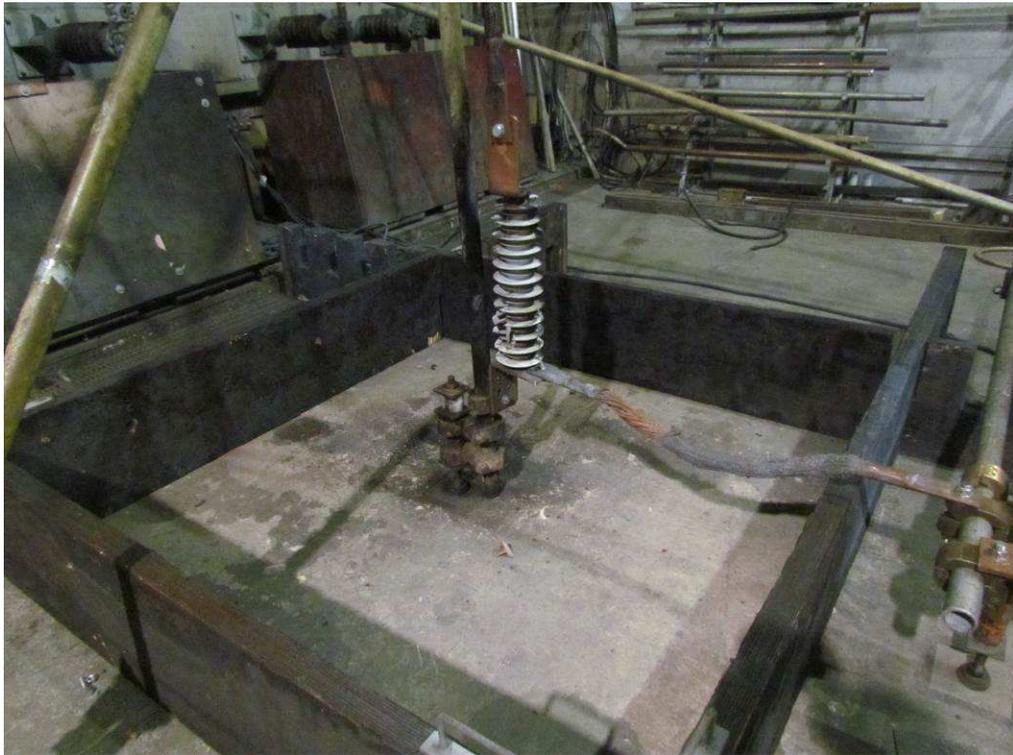
Photo No.8  
After the test No.4

- there was not violent shattering
- the arrester structure remained intact, only polymer housing slid down
- the arrester remained connected to the supply and return circuit
- no fragment were found outside the enclosure
- no flame was noted

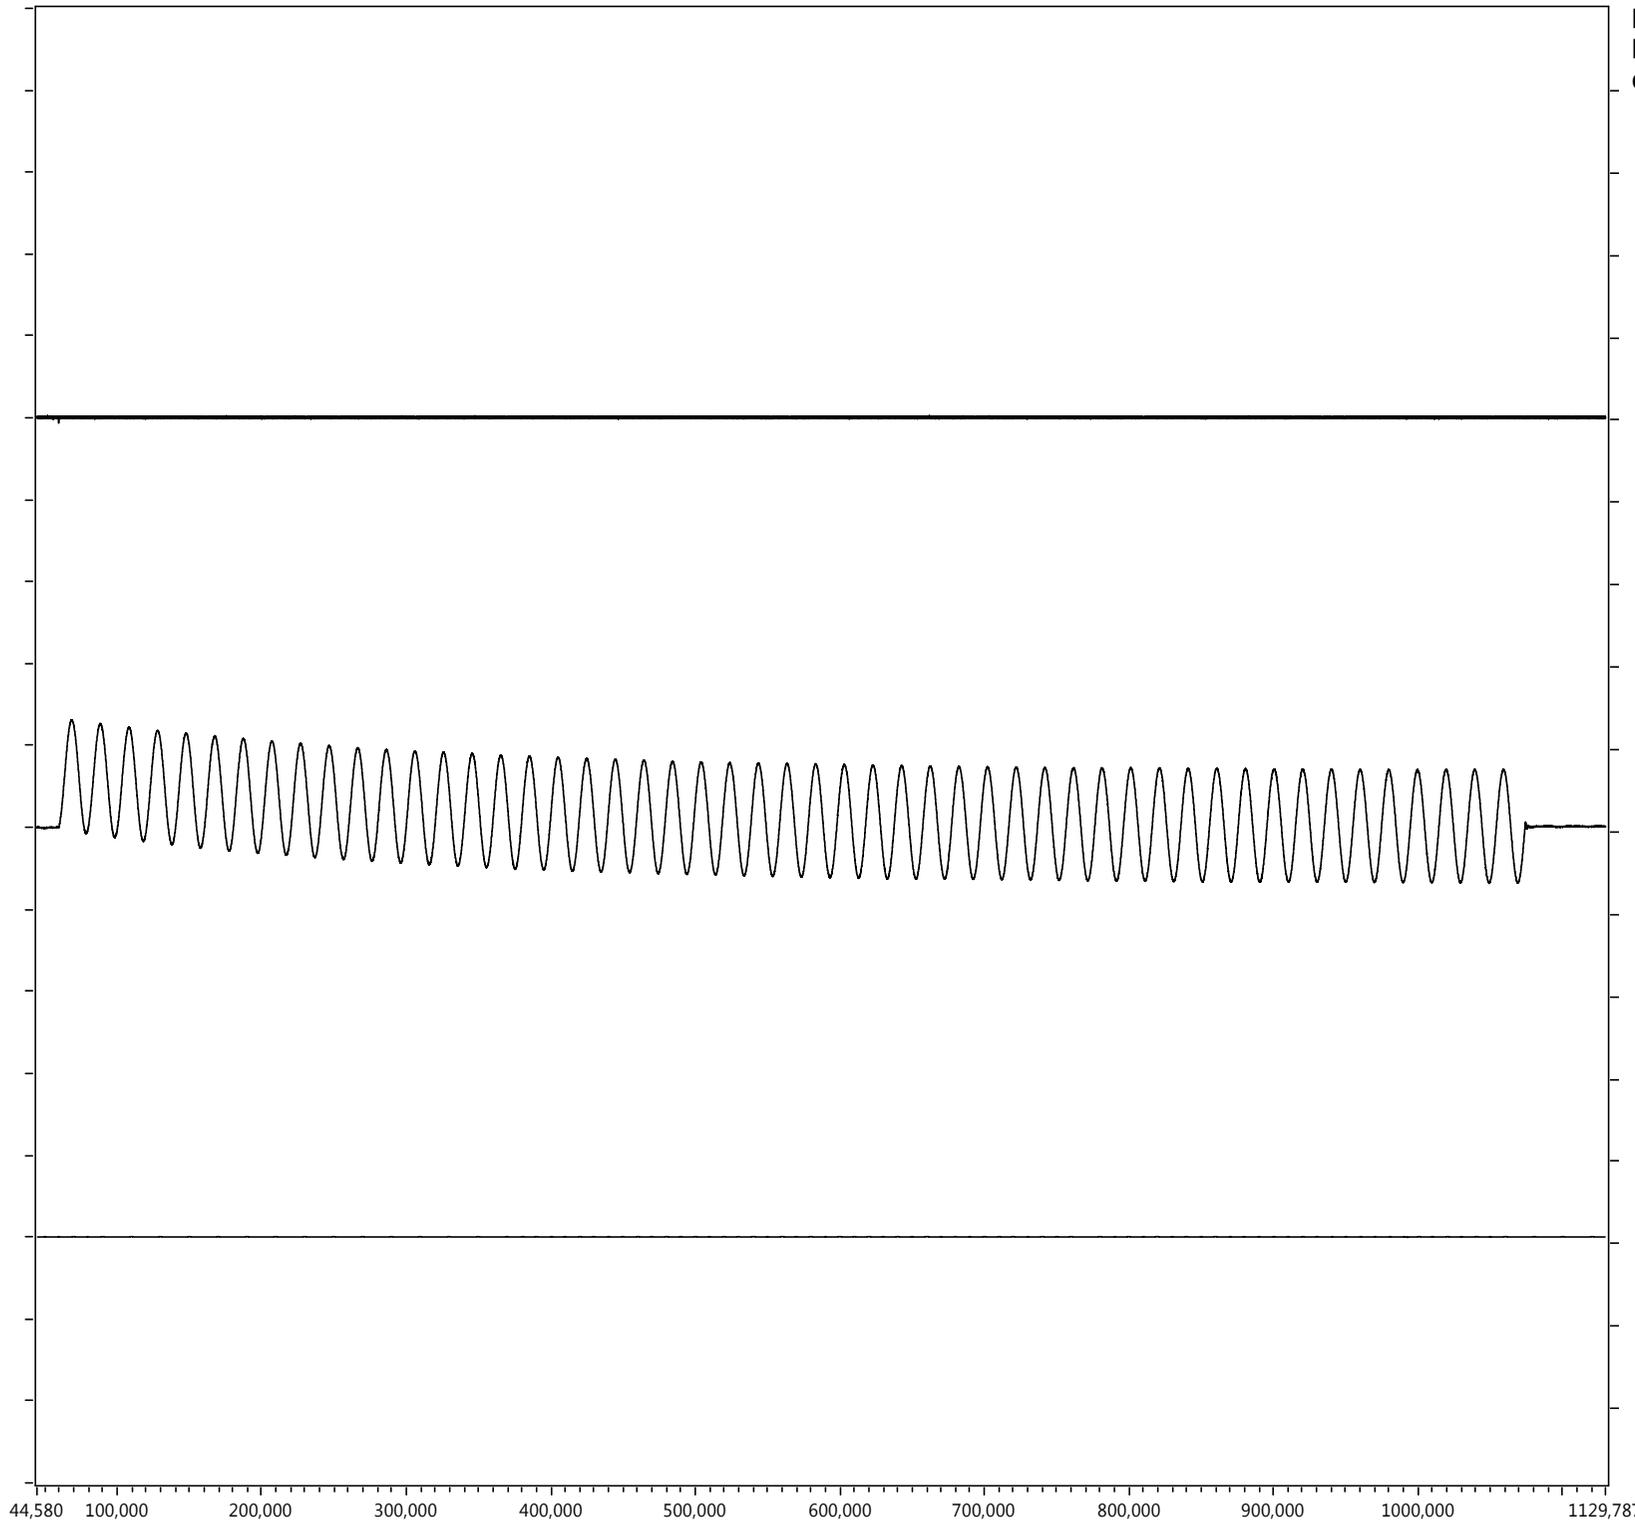
I.peak= 1,57 kA  
I.rms= 611,27 A  
dT= 1,016 Sec

Prospective test current			
Oscillogram		rms value	Peak value
No.	Sheets	A	kA
2	1	611	1,57

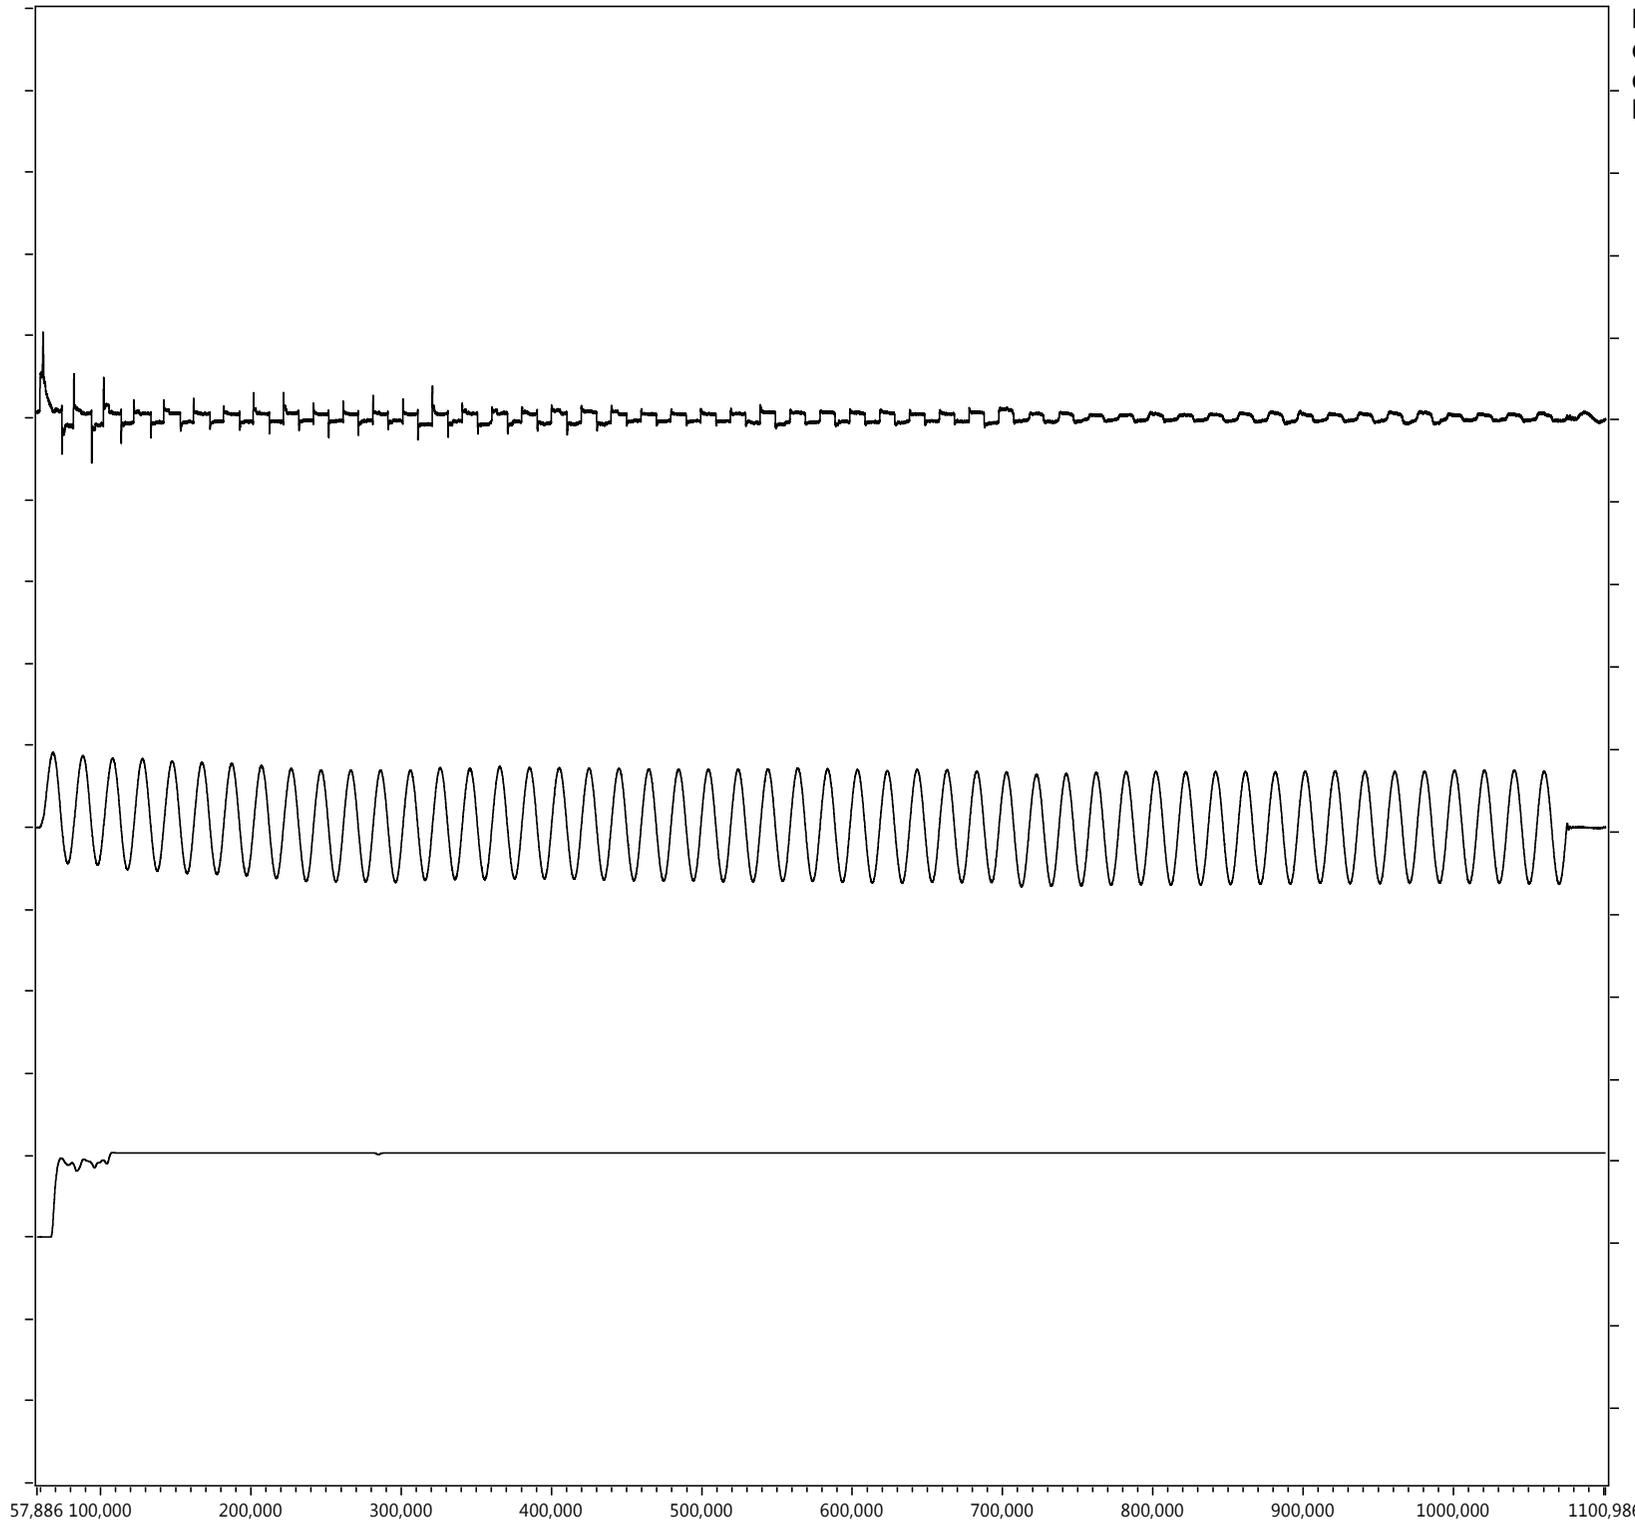
I.peak= 1,10 kA  
dT= 13,3 mSec  
dT= 1,019 Sec  
I.rms= 610,31 A

Test	Oscillogram		Arrester under test	Duration	Test voltage	Test current		Time to flame extinction after the test	Venting time	Notes
						Peak value	rms value			
	Sheets	No.	s	kV	kA	A	s	ms	No.	
1	3	1	5401	1,02	35,4	1,10	610	6,00	13,3	-

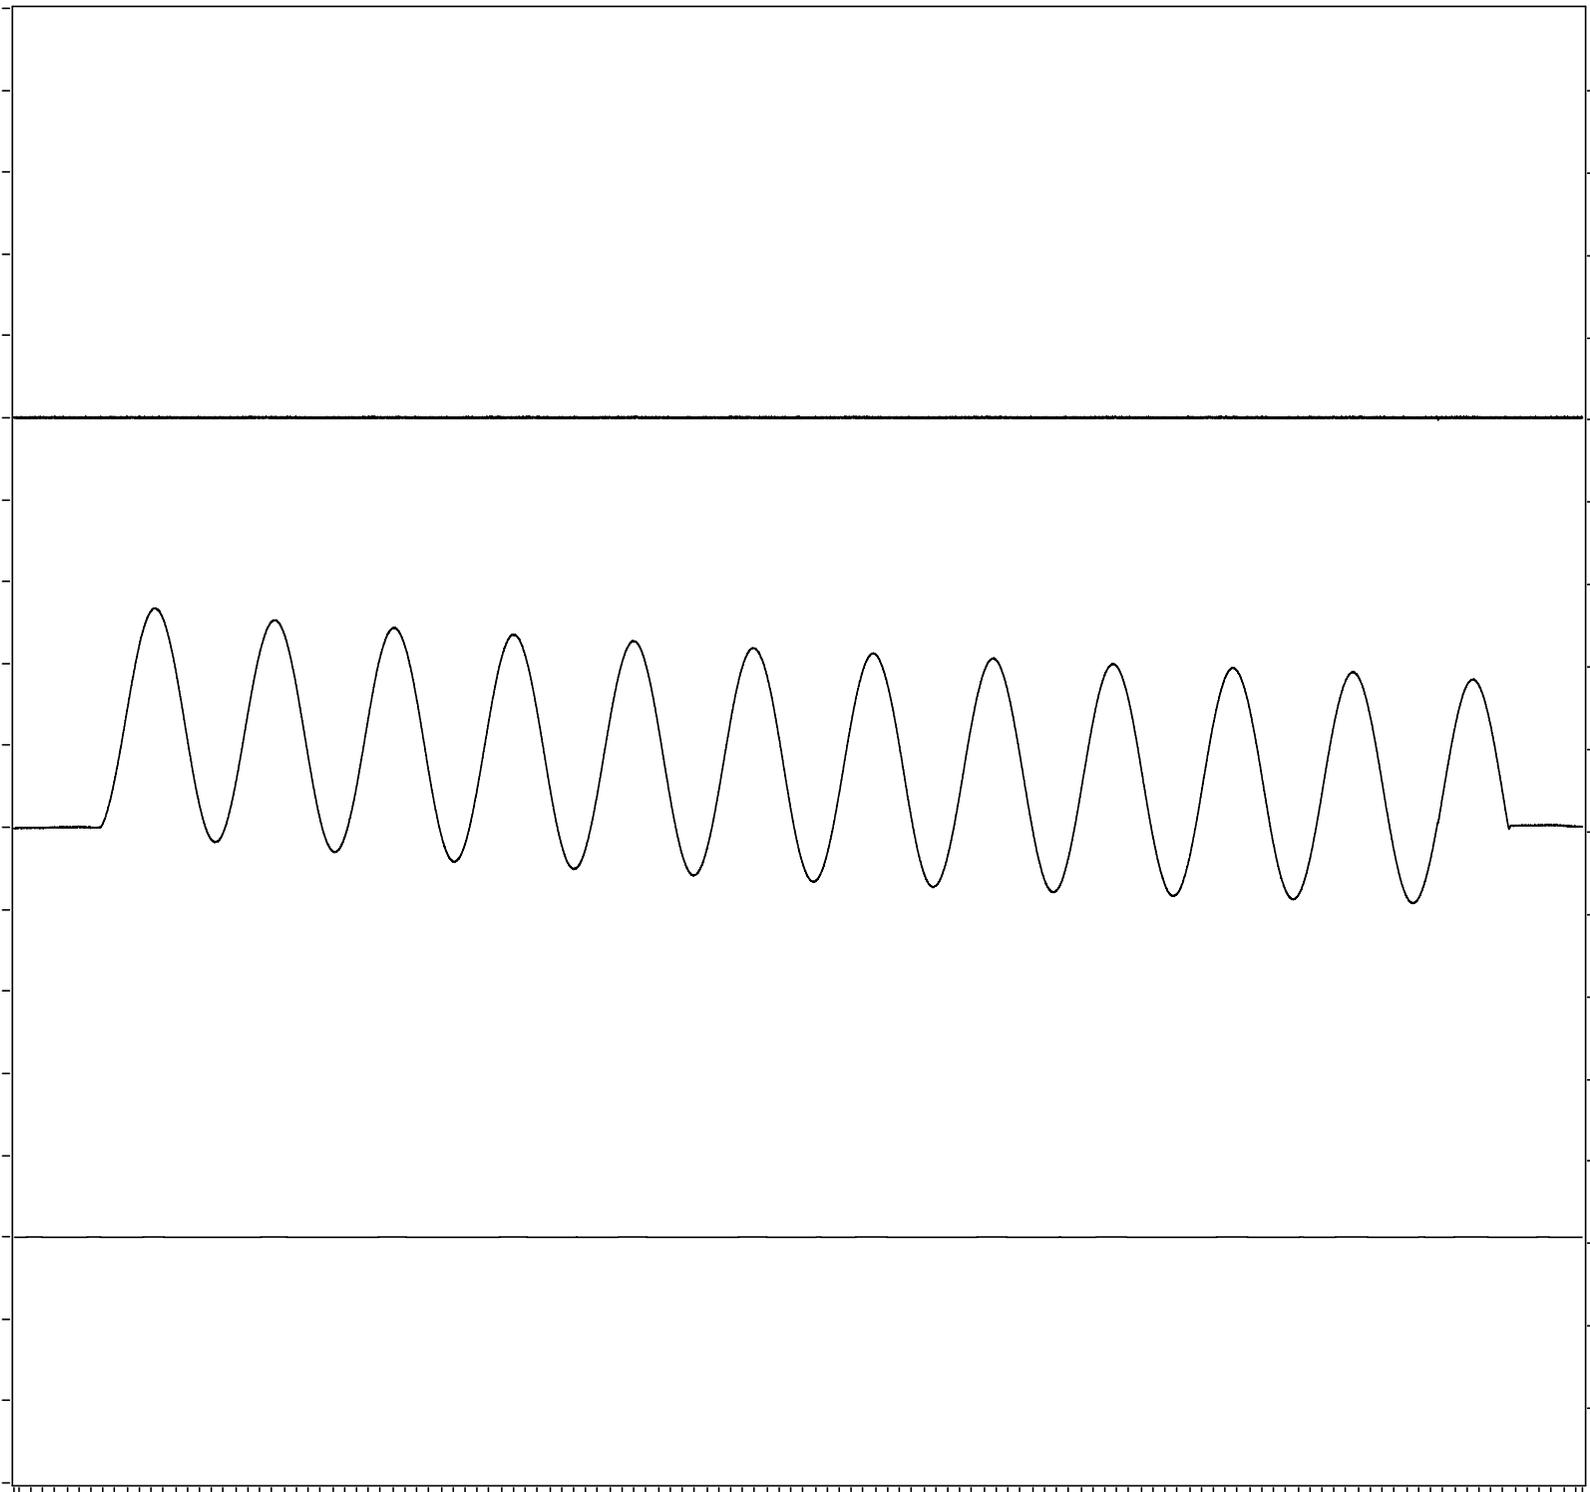
I.rms= 6,17 kA  
I.peak= 16,07 kA  
dT= 234,2 mSec

Prospective test current			
Oscillogram		rms value	Peak value
No.	Sheets	kA	kA
4	1	6,17	16.1

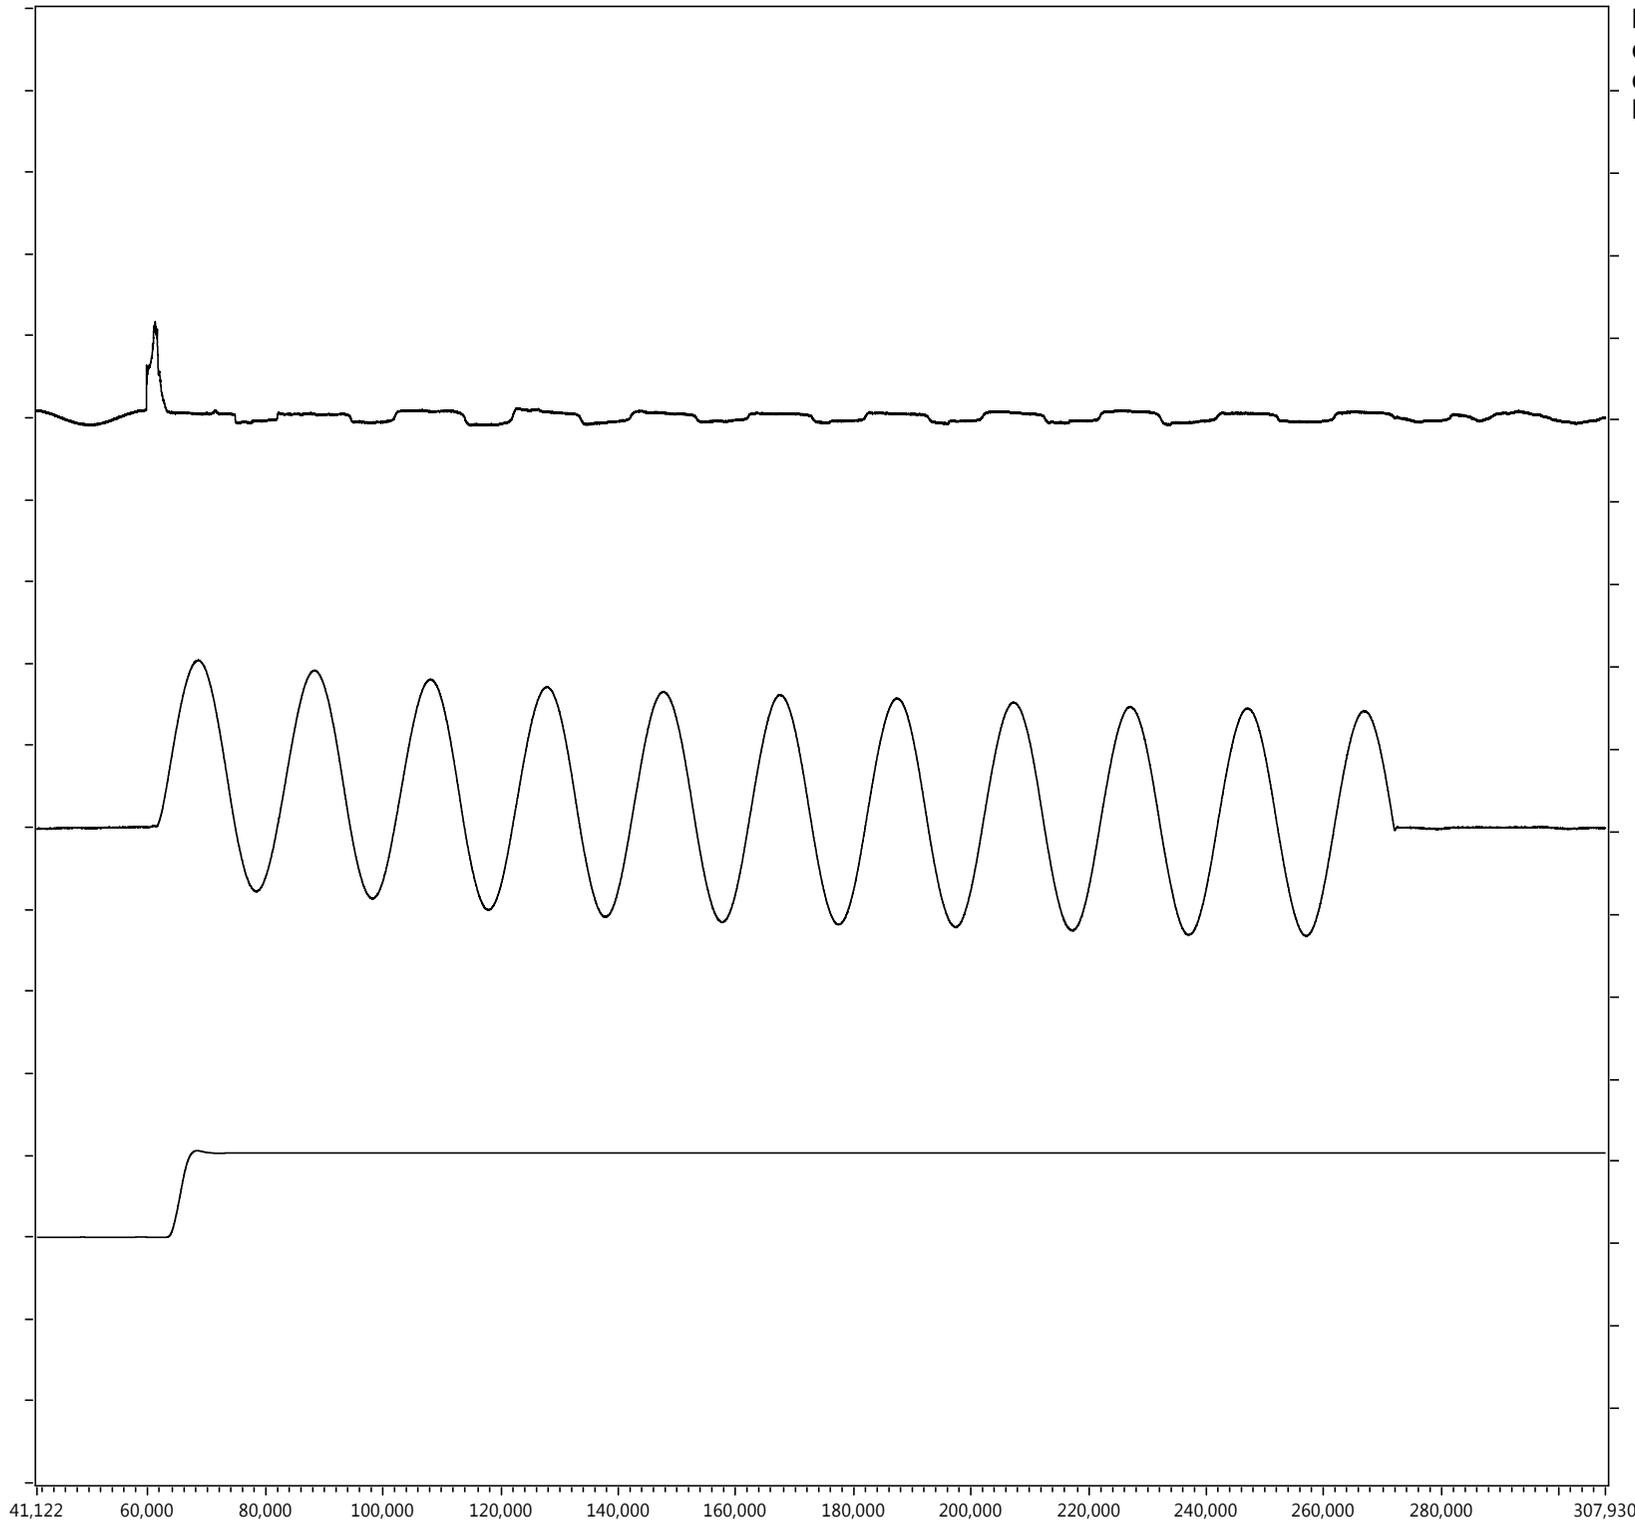
I.peak= 12,27 kA  
dT= 6,0 mSec  
dT= 210,7 mSec  
I.rms= 6,10 kA

Test	Oscillogram		Arrester under test	Duration	Test voltage	Test current		Time to flame extinction after the test	Venting time	Notes
	No.	Sheets				Peak value	rms value			
			No.	s	kV	kA	kA	s	ms	No.
2	5	1	5402	0,21	35,4	12,3	6,10	-	6,0	-

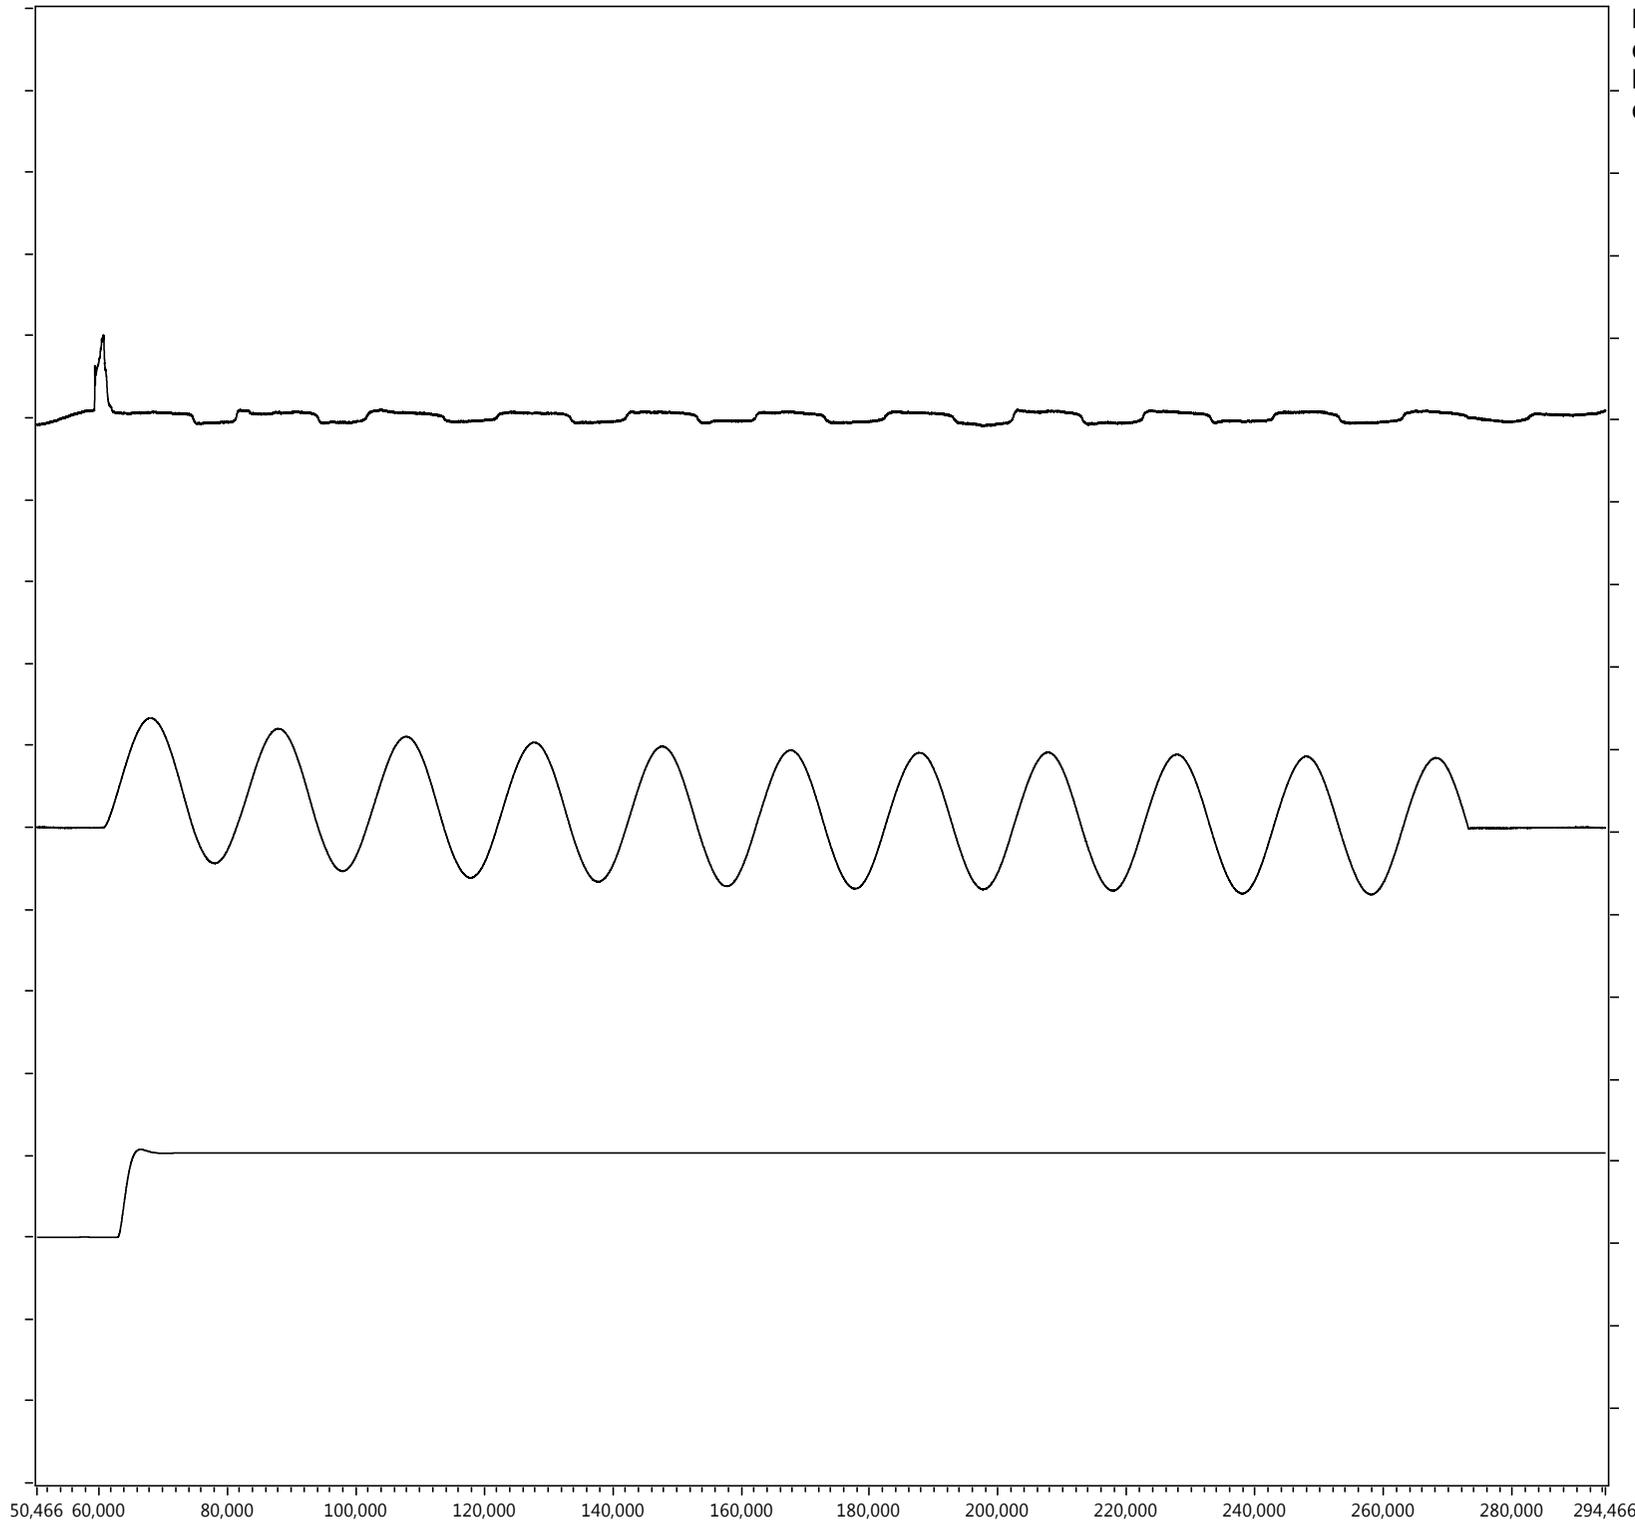
I.peak= 26,76 kA  
dT= 6,3 mSec  
I.rms= 12,14 kA  
dT= 212,2 mSec

Test	Oscillogram		Arrester under test	Duration	Test voltage	Test current		Time to flame extinction after the test	Venting time	Notes
		Sheets				Peak value	rms value			
		No.	s	kV	kA	kA	s	ms	No.	
3	6	1	5403	0,21	35,4	26,8	12,1	-	6,30	-

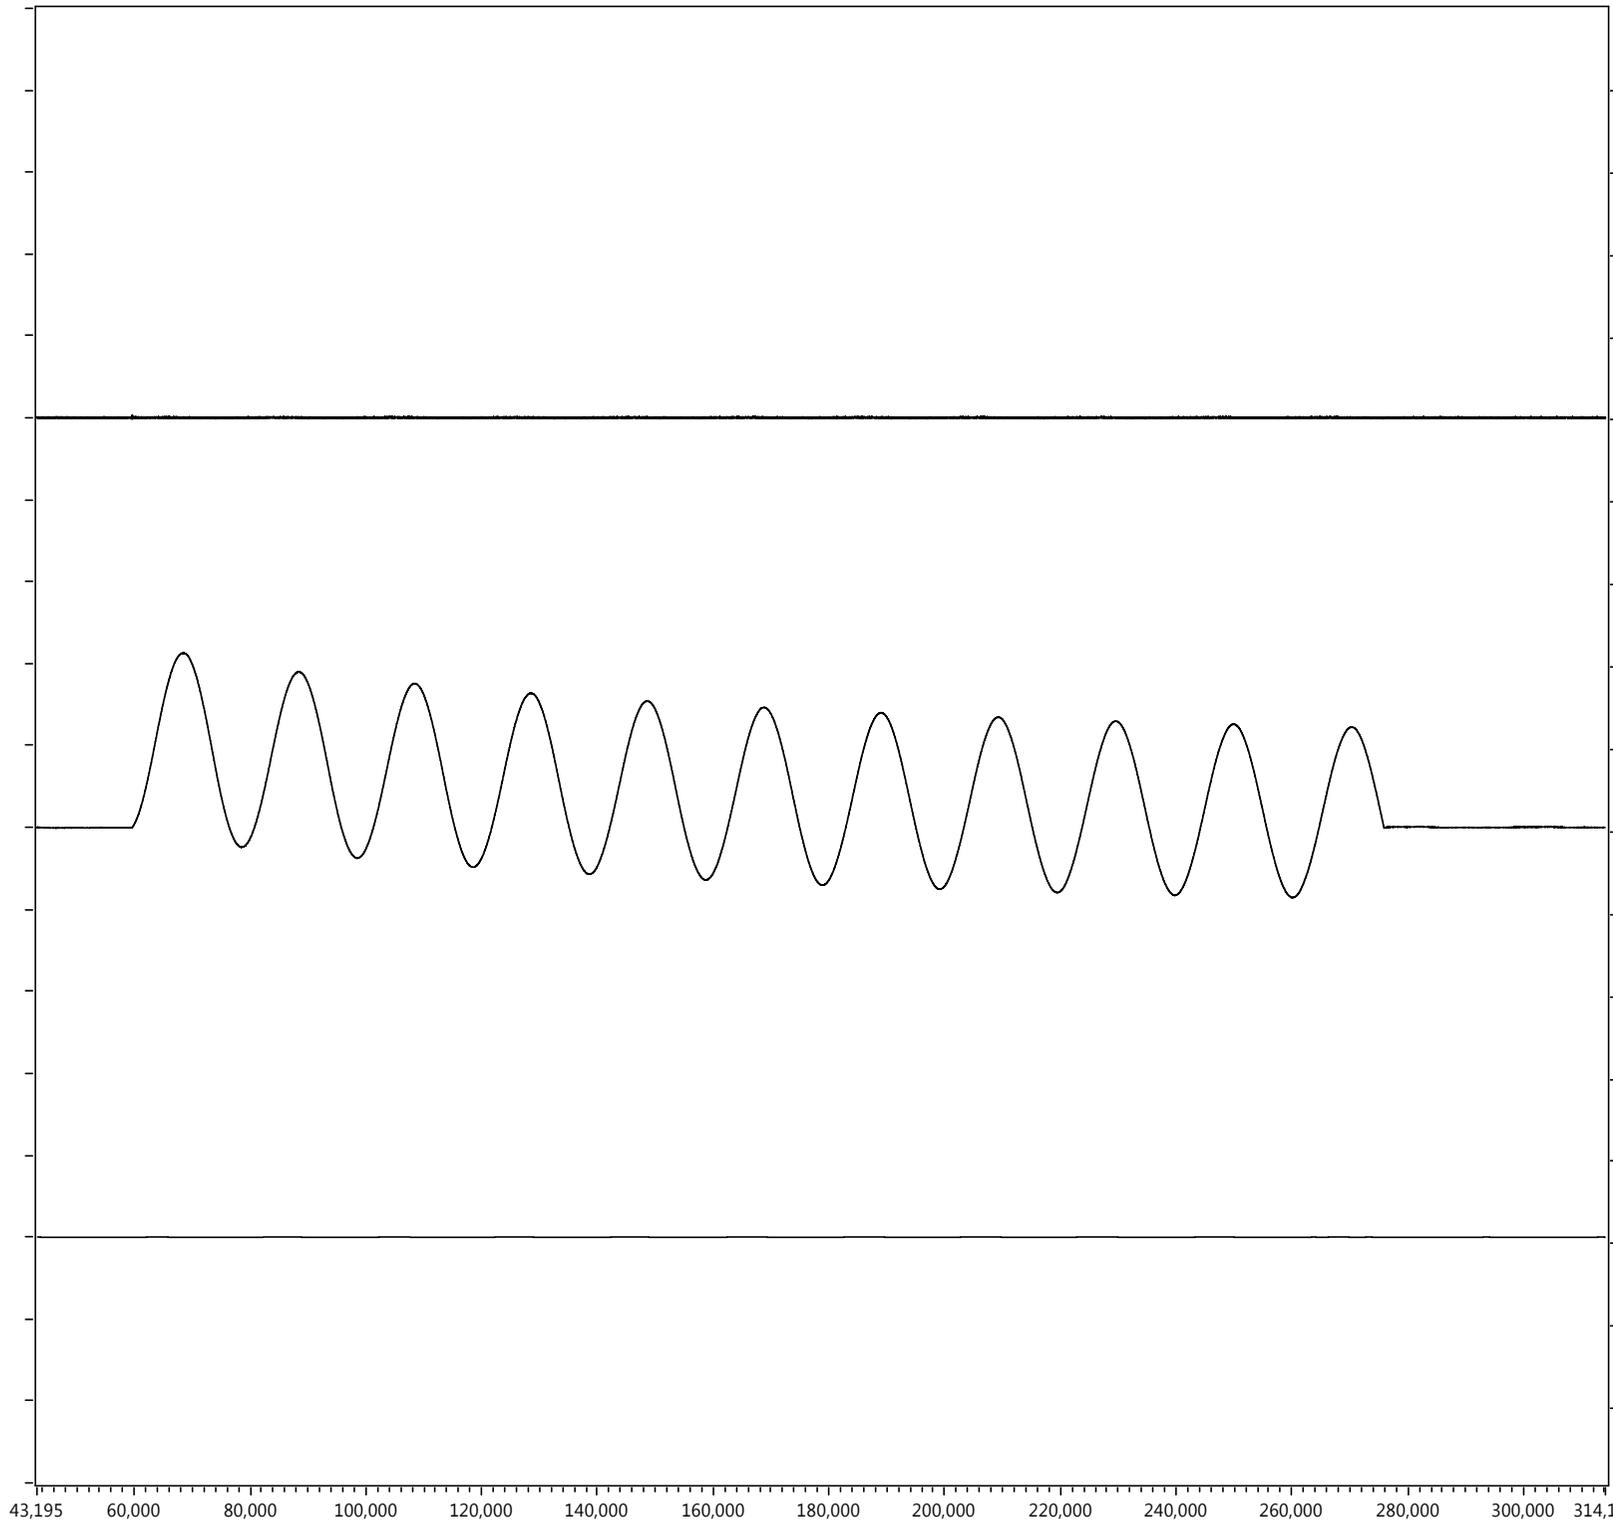
I.peak= 52,27 kA  
I.rms= 20,75 kA  
dT= 217,4 mSec

Prospective test current			
Oscillogram		rms value	Peak value
No.	Sheets	kA	kA
7	1	20,7	52,3
