# Test Report

Document No.	B6022563	Copy No.	1	Number of pages	24
Apparatus	Polymeric housing surge arresters				
Designation	PA-DM				
Serial Number	5401-5402-5403-5404				
Manufacturer	JSC "Polymer-Apparat"				
Client	JSC "Polymer-Apparat" 195427, Saint-Petersburg, Ak. Konstantinova Str.,1 - Russia Federation				
Tested for	-				
Date(s) of tests	October 21, 2016				
Tested by	CESI S.p.A. Via Rubattino, 54 20134 Milano – Italy				
Test performed	Short circuit tests

IEC 60099-4 (2014-06)

<b>Metal-oxide surge arrester</b>	
Manufacturer	Joint-Stock Company Polymer-Apparat
Type	PA-DM
Drawing	
Rated voltage (Ur)	54,0 kV
Maximum continuous operating voltage (Uc)	43,2 kV
Rated frequency	50/60 Hz
Nominal discharge current (8/20 $\mu$ s impulse shape)	5 kA
Arrester classification	DM
Rated short circuit current	
High current	for 0,20 s ; 20,0 kA
Low current	for 1,00 s ; 0,6 kA

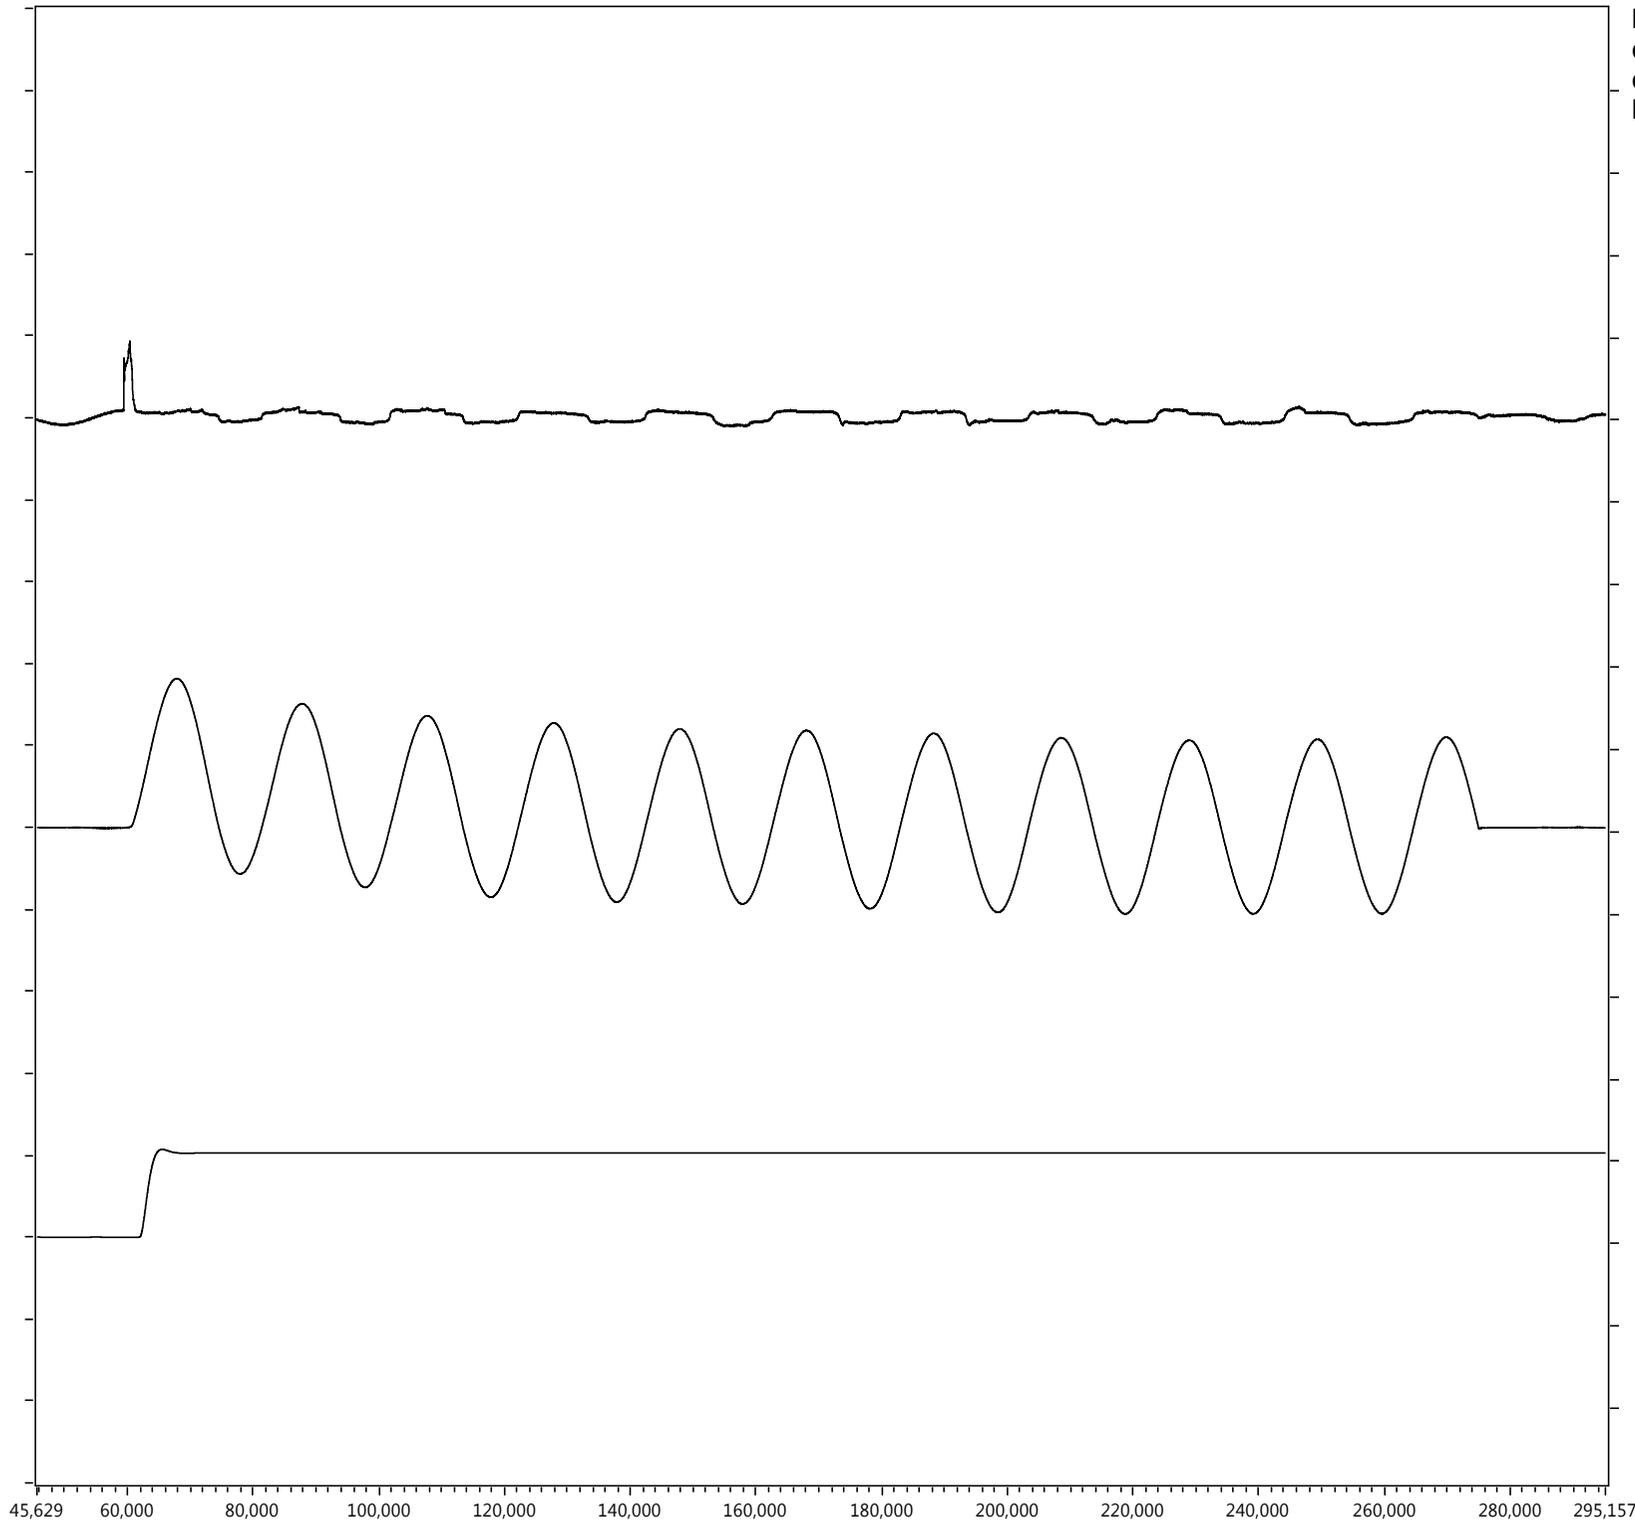
I.peak= 45,49 kA  
dT= 4,6 mSec  
dT= 214,8 mSec  
I.rms= 20,26 kA

Test	Oscillogram		Arrester under test	Duration	Test voltage	Test current		Time to flame extinction after the test	Venting time	Notes
						Peak value	rms value			
	Sheets	No.	s	kV	kA	kA	s	ms	No.	
4	8	1	5404	0,21	35,4	45,5	20,2	-	4,6	-
