Attachment 9_Shock and Vibration Test Report

TEST REPORT

Report No. : SGS-R18-0000-EN00
Order No. : TON-R18-0466
Applicant : CU Medical Systems, Inc.
Address : 130-1, Dongwhagongdan-ro, Munmak-eup, Wonju-si, Gangwon-do, Korea
Product : Cardiac Defibrillator & Monitor
Model No. : CU-HD1
Date of Test : February 19, 2018 ~ March 27, 2018
Standard : Request of client
Test Result : Refer to Page 22
Use of Report : CB Progressive

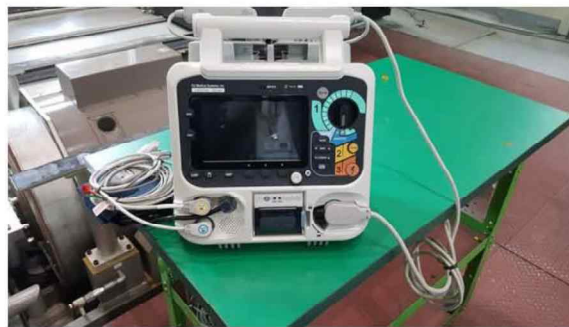
2.2 Photograph

| 3) Product | : Cardiac Defibrillator & Monitor |
| 4) Model | : CU-HD1 |

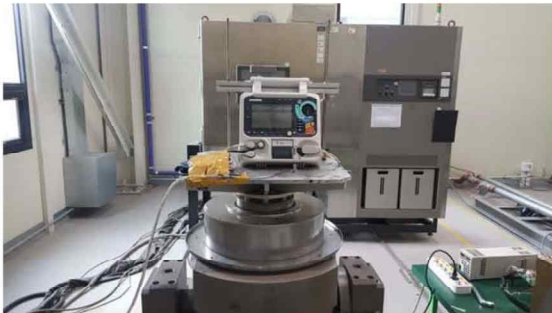
Test axis	Test photograph
Vertical (Z)

1) Test Type : Random

3) Test time : 1 h 30 min in total (30 min in each axis)

5) Sample condition : Unpackaged/Non operation

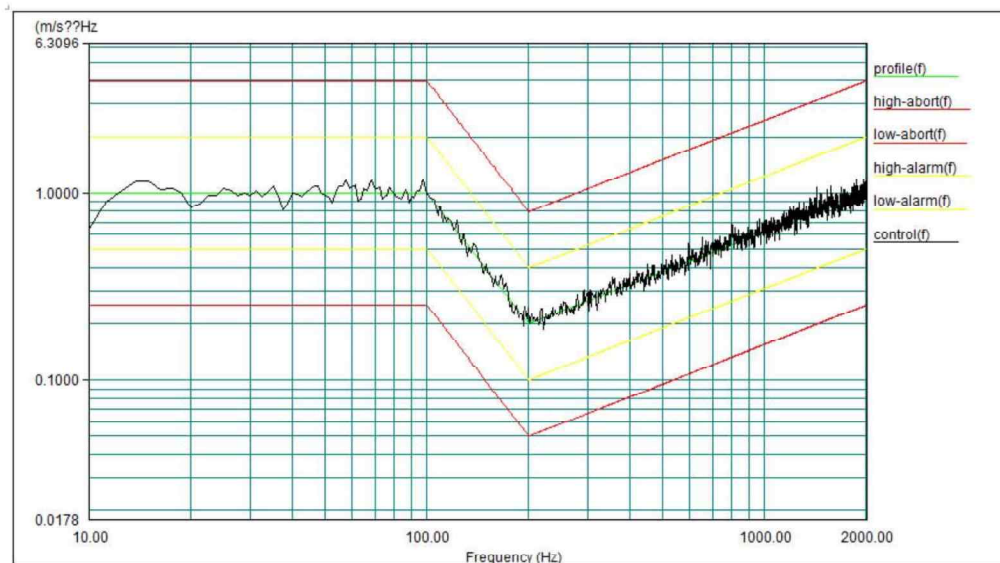
※ Appendix 1. Vibration test Data _ Vertical (Z)

Control RMS: 36.448818 m/s² Full Level Elapsed Time: 00:30:00

Demand RMS: 35.902779 m/s² Remaining Time: 00:00:00

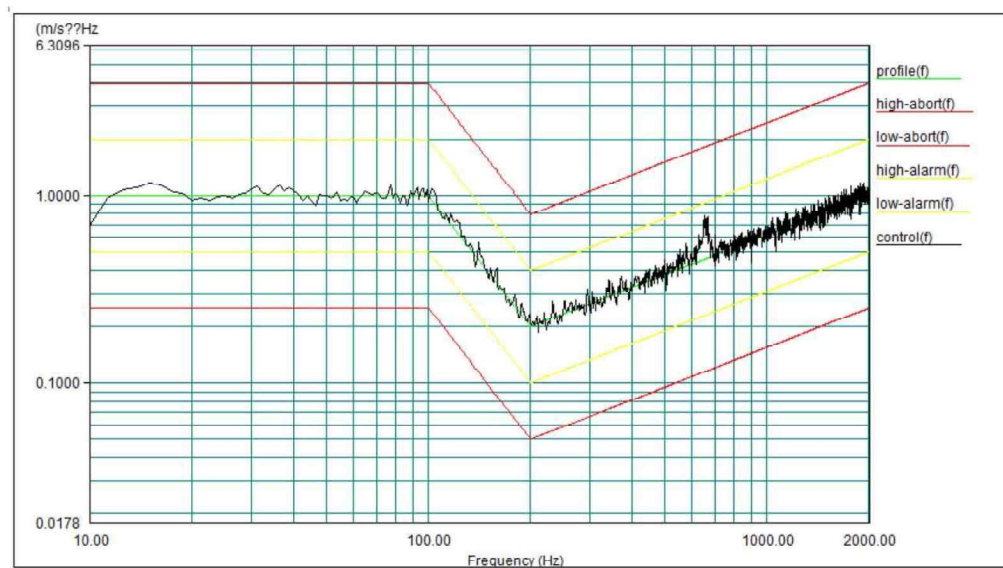
-. Vibration test Data _ Transverse (X)

Control RMS: 36.629372 m/s² Full Level Elapsed Time: 00:30:00

Demand RMS: 35.902779 m/s² Remaining Time: 00:00:00

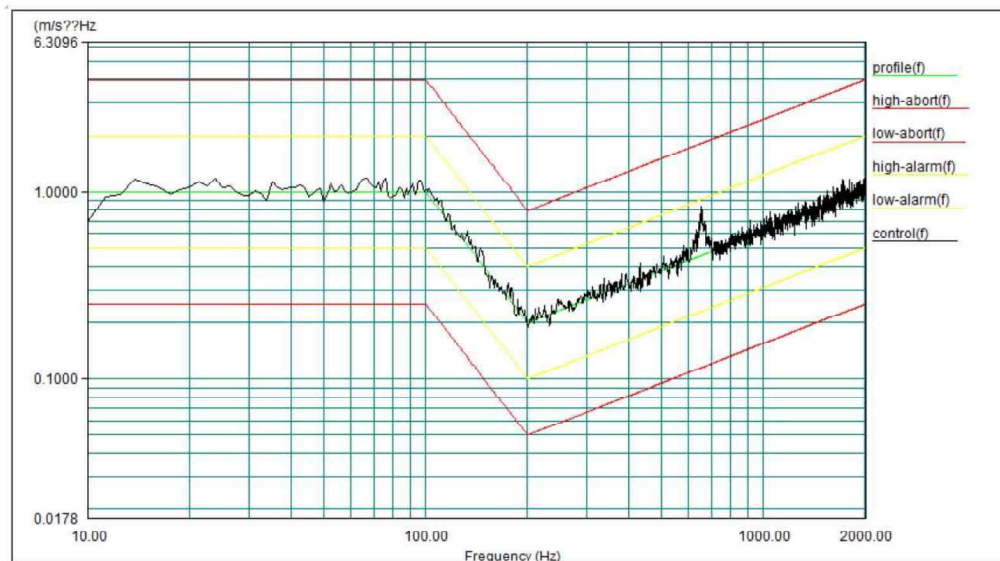
-. Vibration test Data _ Longitudinal (Y)

Control RMS: 36.638527 m/s² Full Level Elapsed Time: 00:30:00

Demand RMS: 35.902779 m/s² Remaining Time: 00:00:00

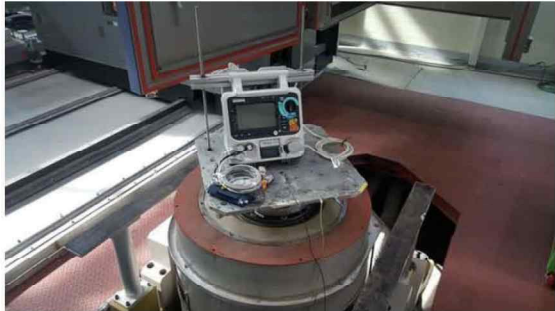
Test axis	Test photograph
Vertical (Z)

- 1) Test Type : Half sine
- 2) Acceleration : 300 m/s²
- 3) Duration : 11 ms
- 4) Number of shocks : 18 times in total (±3 times in each axis)
- 5) Test axis : Transverse (X), Longitudinal (Y), Vertical (Z)
- 6) Sample condition : Unpackaged/Non operation
- 7) Sample quantity : 1 EA

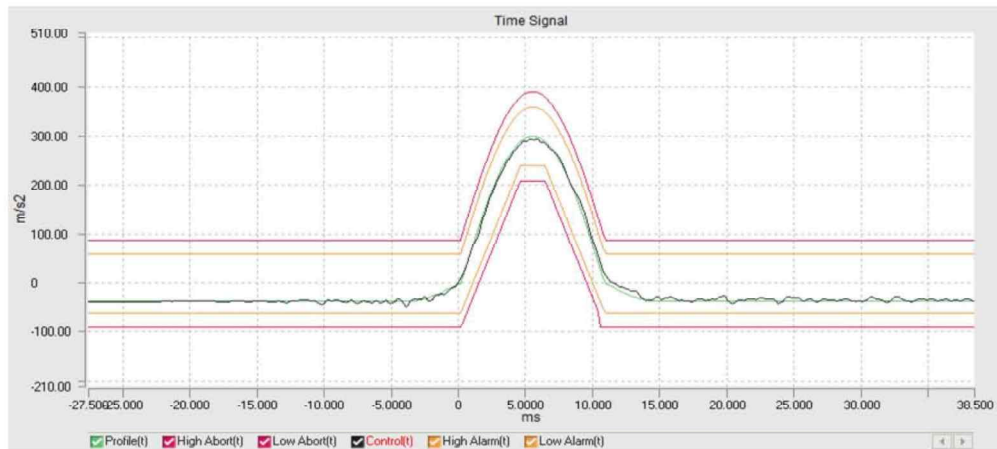
※ Appendix 1. Shock test Data _ Vertical (Z)

Shock Type: Half Sine Mag: 300.00 m/s² Pulse Duration: 11 ms^{1/2}
Current level: 100 % Demand peak: 300.000 m/s² Control peak: 294.159 m/s²
Block Size: 1024 Frame Time: 0.1707 s dT: 0.000166667 s^{1/2}
Current Pulses: 3 Output pulses: 12 Remain pulses: 0^{1/2}
Data was saved as a file at time: 2018-3-27 AM 10:29:26^{1/2}

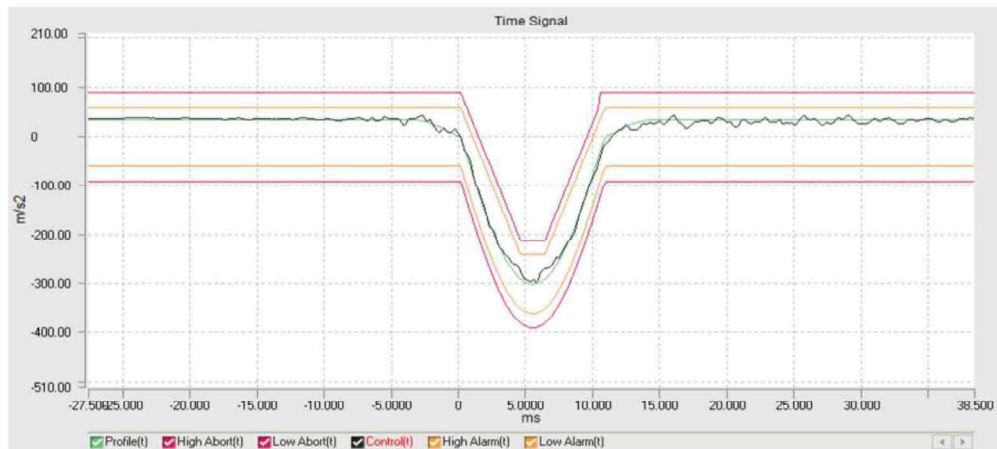
Shock Type: Half Sine Mag: 300.00 m/s² Pulse Duration: 11 ms^μ
Current level: 100 % Demand peak: 300.000 m/s² Control peak: 297.383 m/s²
Block Size: 1024 Frame Time: 0.1707 s dT: 0.000166667 s^μ
Current Pulses: 3 Output pulses: 12 Remain pulses: 0^μ
Data was saved as a file at time: 2018-3-27 AM 10:29:34^μ

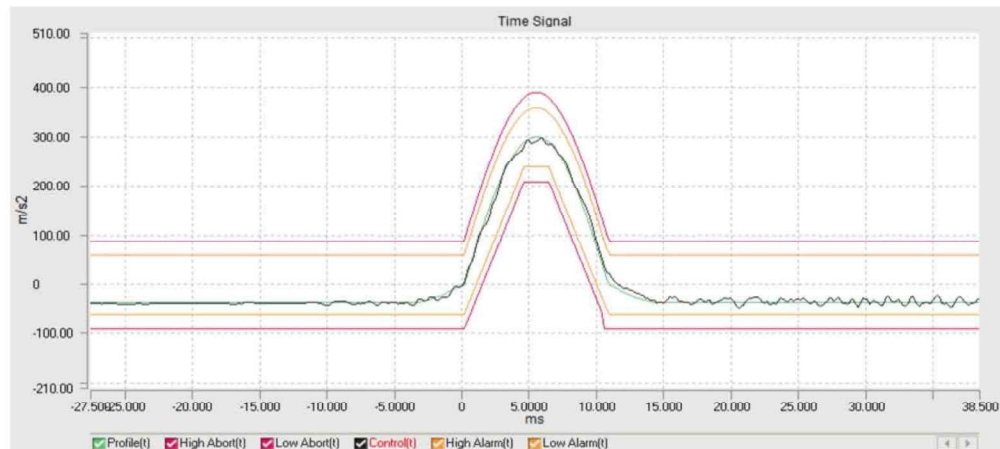
-. Shock test Data _ Transverse (X)

Shock Type: Half Sine Mag: 300.00 m/s^2 Pulse Duration: 11 ms⁺
Current level: 100 % Demand peak: 300.000 m/s^2 Control peak: 298.088 m/s^2
Block Size: 1024 Frame Time: 0.1707 s dT: 0.000166667 s⁺
Current Pulses: 3 Output pulses: 12 Remain pulses: 0⁺
Data was saved as a file at time: 2018-3-27 AM 10:06:53⁺

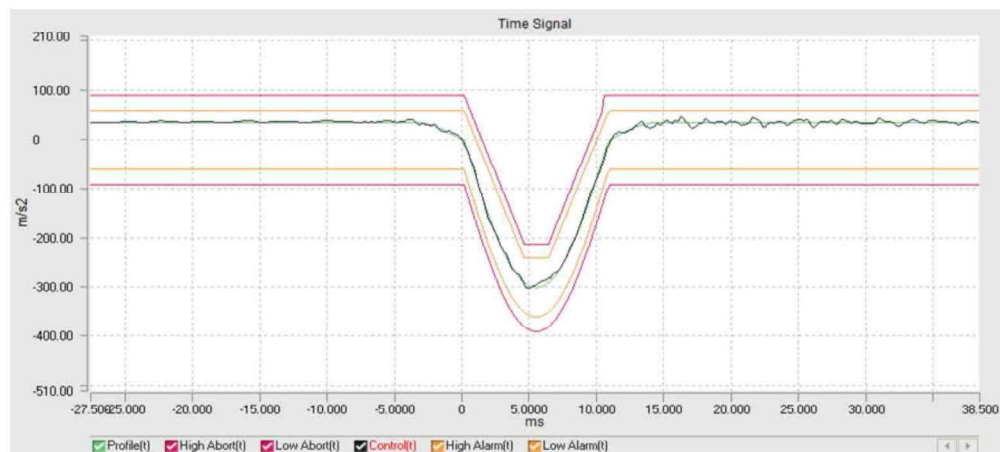
Shock Type: Half Sine Mag: 300.00 m/s² Pulse Duration: 11 ms^μ
Current level: 100 % Demand peak: 300.000 m/s² Control peak: 301.797 m/s²^μ
Block Size: 1024 Frame Time: 0.1707 s dT: 0.000166667 s^μ
Current Pulses: 3 Output pulses: 12 Remain pulses: 0^μ
Data was saved as a file at time: 2018-3-27 AM 10:07:20^μ

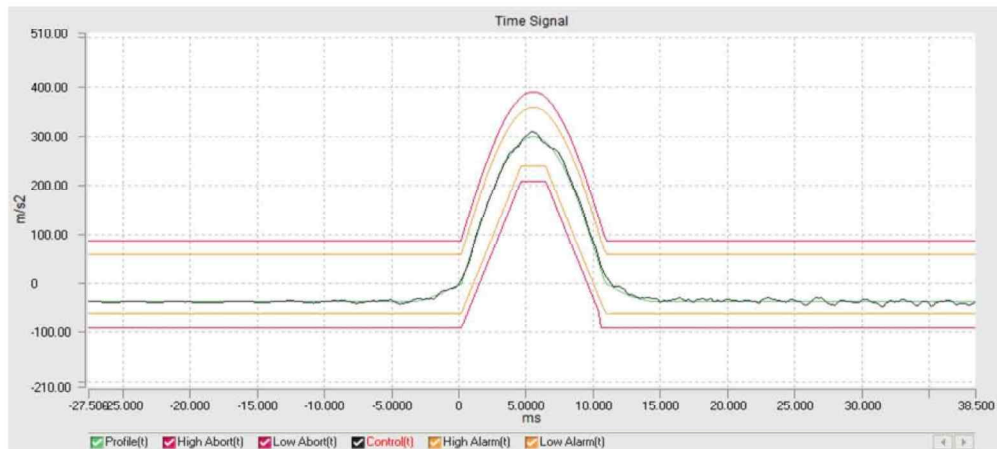
-. Shock test Data _ Longitudinal (Y)

Shock Type: Half Sine Mag: 300.00 m/s² Pulse Duration: 11 ms^μ
Current level: 100 % Demand peak: 300.000 m/s² Control peak: 311.276 m/s²
Block Size: 1024 Frame Time: 0.1707 s dT: 0.000166667 s^μ
Current Pulses: 3 Output pulses: 12 Remain pulses: 0^μ
Data was saved as a file at time: 2018-3-27 AM 09:40:06^μ

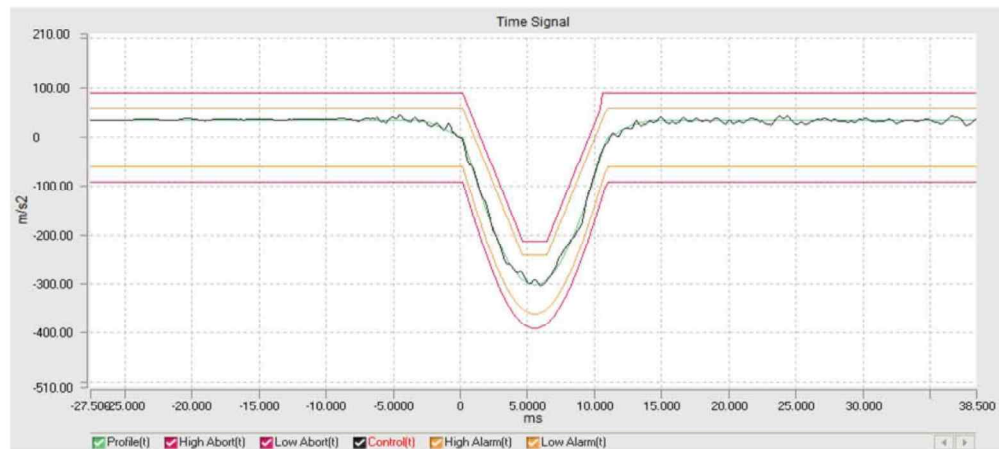
Shock Type: Half Sine Mag: 300.00 m/s² Pulse Duration: 11 ms^μ
Current level: 100 % Demand peak: 300.000 m/s² Control peak: 303.298 m/s²
Block Size: 1024 Frame Time: 0.1707 s dT: 0.000166667 s^μ
Current Pulses: 3 Output pulses: 12 Remain pulses: 0^μ
Data was saved as a file at time: 2018-3-27 AM 09:57:18^μ

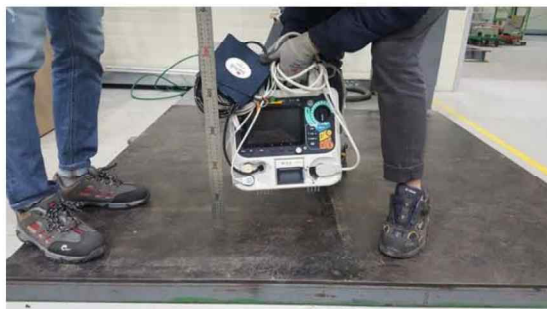
(4) Test photograph

- 1) Drop height : 0.1 m
- 2) Drop orientation : 1 Faces
- 3) Number of drops : 1 times in total
- 4) Sample state : Unpackaged/Non-operation
- 5) Check time : Before, After the test
- 6) Sample quantity : 1 EA

Check list	Test result
1. Visual inspection -. Mechanical damage such as deformation, loosening of screw, separation, crack, etc	No abnormal was found
2. Performance check -. Display check	Refer to ※ Annex 1.

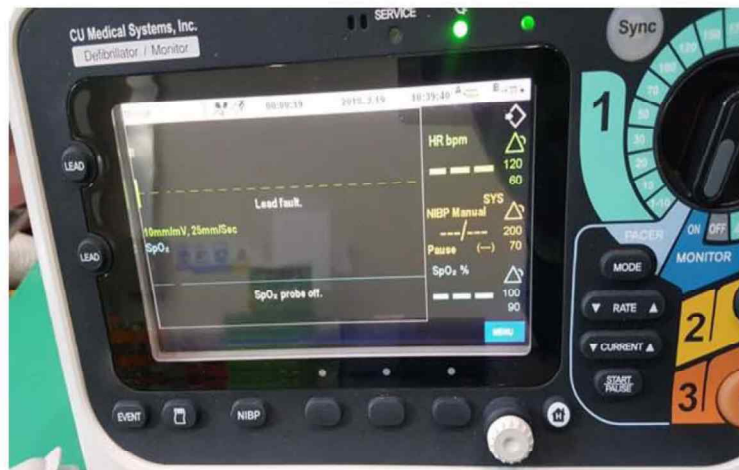
Before
The
test

Display check

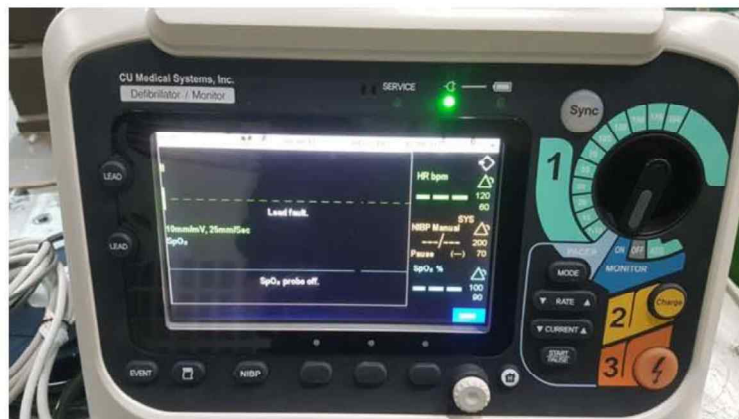
After
The
Test
(Vibration)

Check list	Test result
1. Visual inspection -. Mechanical damage such as deformation, loosening of screw, separation, crack, etc	No abnormal was found
2. Performance check -. Display output check	Refer to ※ Annex 1.

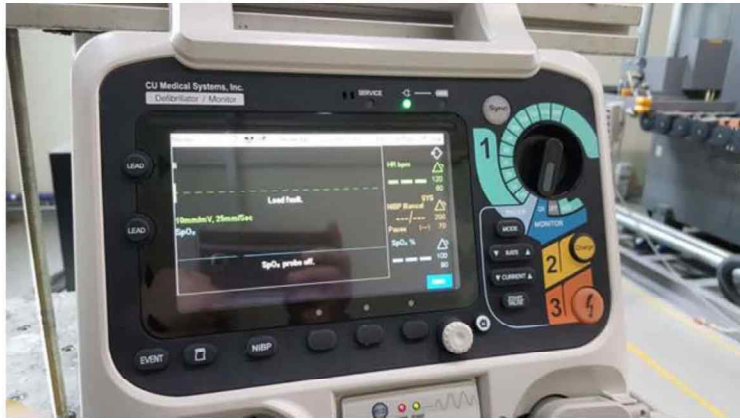
Display check	
After The Test (Shock)

Check list	Test result
1. Visual inspection -. Mechanical damage such as deformation, loosening of screw, separation, crack, etc	No abnormal was found
2. Performance check -. Display output check	Refer to ※ Annex 1.
