# TEST REPORT

NO.: ECT2019K040218-Y1

**Sample name:** LED street light

According to customer requirements, to do IK06 test on the submitted sample(s).

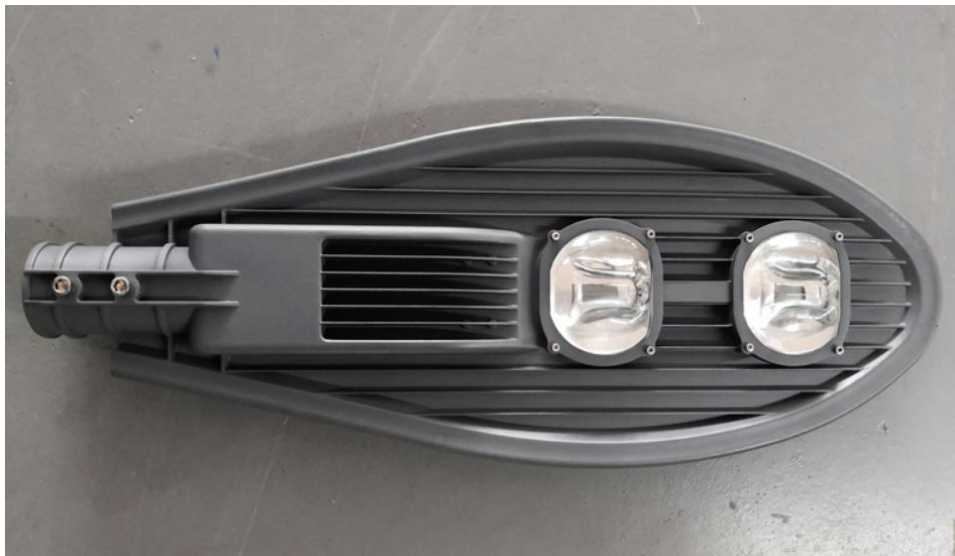
## Photos of the sample:

Test Item	Criteria (According to the technical requirements of client)	Test Result	
IK06	No crack on the sample	After the test, there is no obvious appearance abnormality on the sample.	P

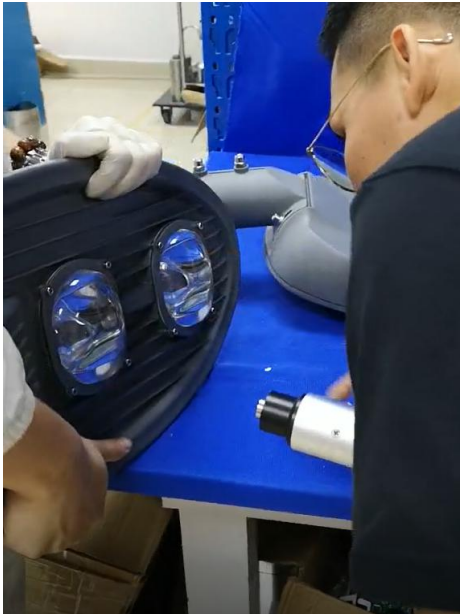
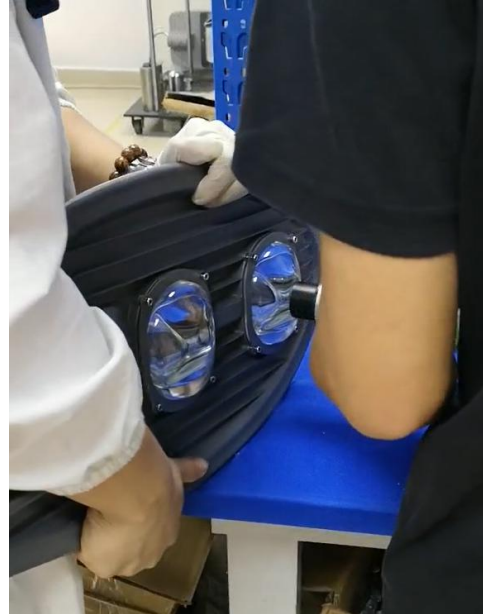
## Photos of the Testing:

- 1) Ambient temperature and relative humidity: 23.5°C, 58% RH
- 2) Test condition:
  - a) The sample is placed on the ground, The energy of impact test specimens for 1J;
  - b) The impact point is uniformly distributed on the sample
  - c) Check the samples after test
