# TEST REPORT

NO.: ECT2019K040218-Y1

**Sample name:** LED street light

**Model:** Range Leaf, sizes G1200, G1700, G2600, G3500, G3800, G5200

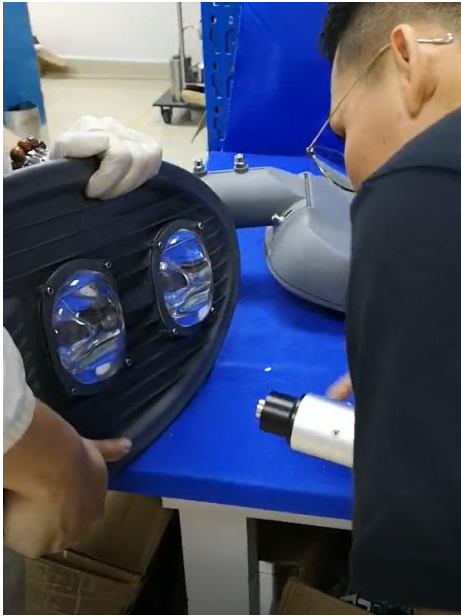
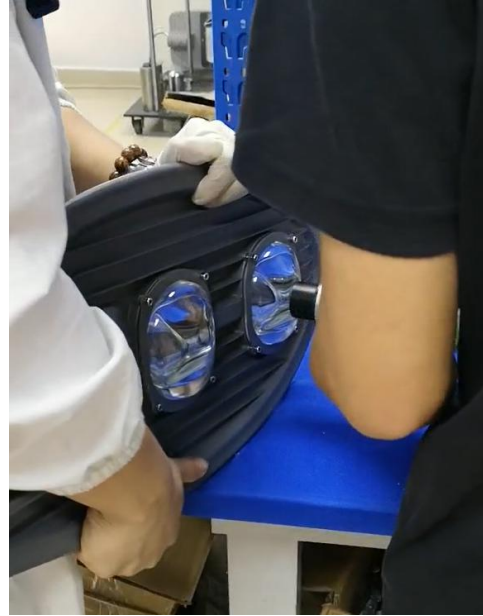
## Photos of the Testing:

- 1) Ambient temperature and relative humidity: 23.5°C, 58% RH
- 2) Test condition:
  - a) The sample is placed on the ground, The energy of impact test specimens for 1J;
  - b) The impact point is uniformly distributed on the sample
  - c) Check the samples after test

Equipment	Manufacturer	Model	Calibration Date
IK Impact Tester	Hanyang	HY-7812A	2019-03-15

Test Item	Criteria (According to the technical requirements of client)	Test Result	
IK08	No crack on the sample	After the test, there is no obvious appearance abnormality on the sample.	P
