Certificate of Conformance for Freight Container Mechanical Seal Testing
Seal Classification: High security seal

試驗報告 TEST REPORT

SUBJECT : Freight containers Mechanical seals classification Testing

Name of Article : Cable Seal

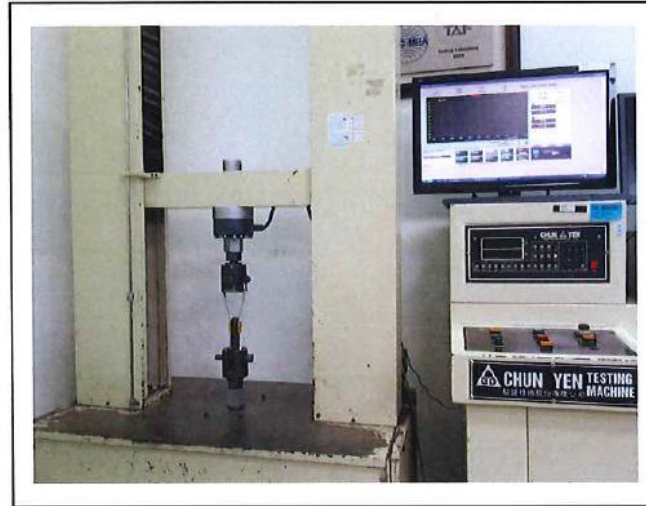
Testing Instrument : Universal Testing Machine (No.TG0103)

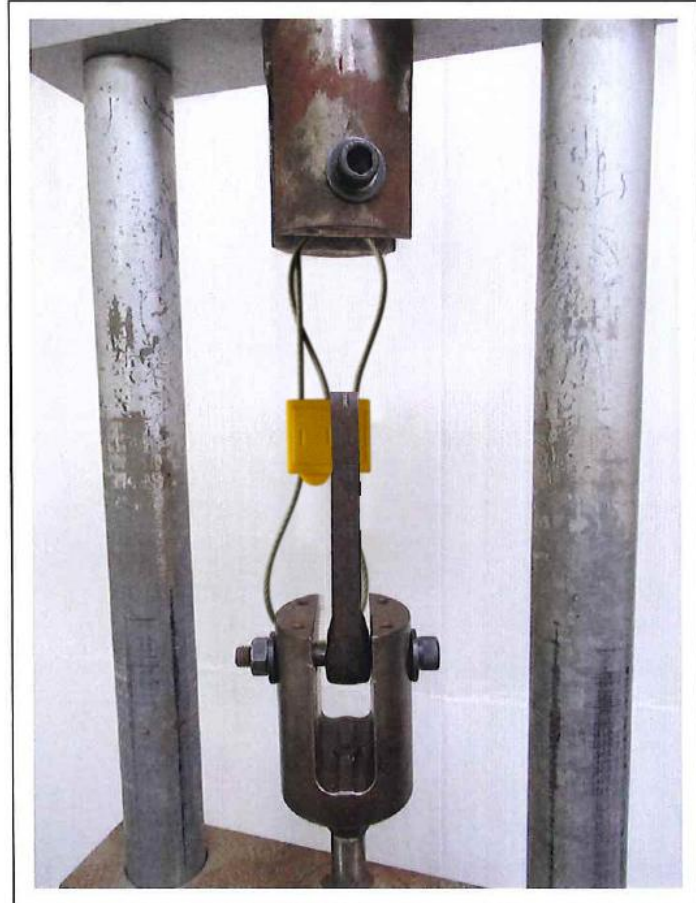
Impact Set up

The impact load is applied at the locking mechanism of the seal in the direction opposite the direction used in locking the seal.

The impact test is performed at 18 degrees C and minus 27 degrees C of temperature.

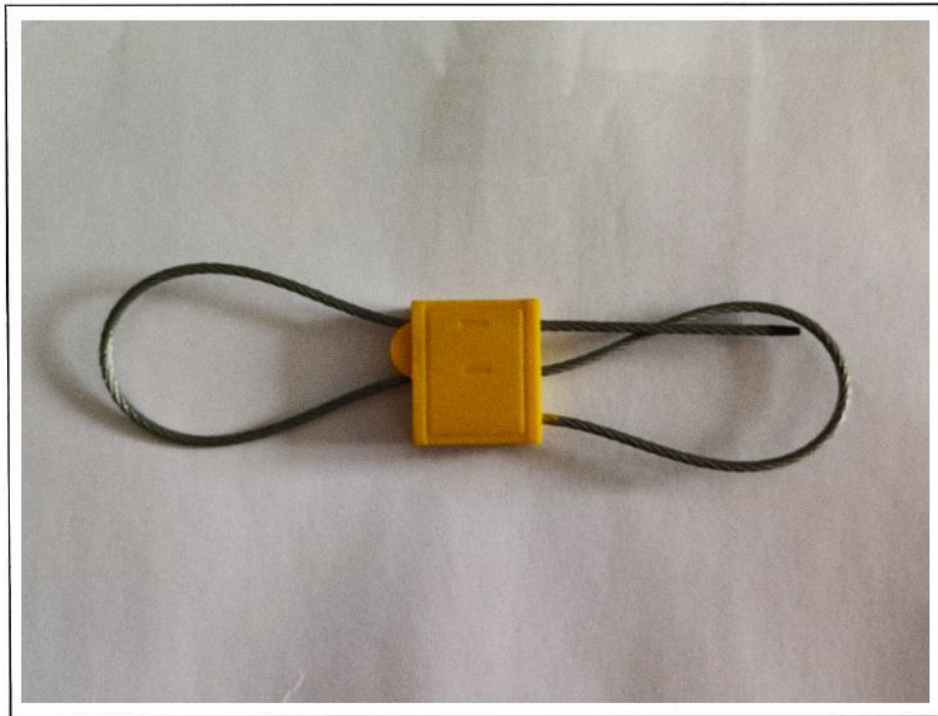
Name of Article : Cable Seal

Type : US-CC202
