CERTIFICATE OF CONSTANCY OF PERFORMANCE

ROAD RESTRAINT SYSTEM

Passco L1 H1-A-W4 (ES 2.00)

Installation manual passco H1-A-W4

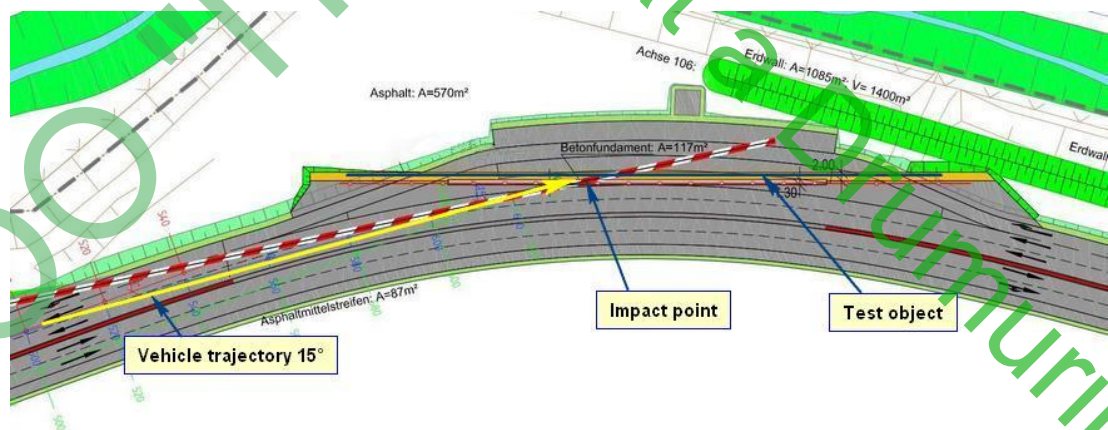
4.2.2 Sketch of vehicle approach to indicated impact point

The test site consists of an approach road of approximately 600 m and a test area on the outer side of a curve in the road of 160 x 20 m. In this area the road restraint system was installed.

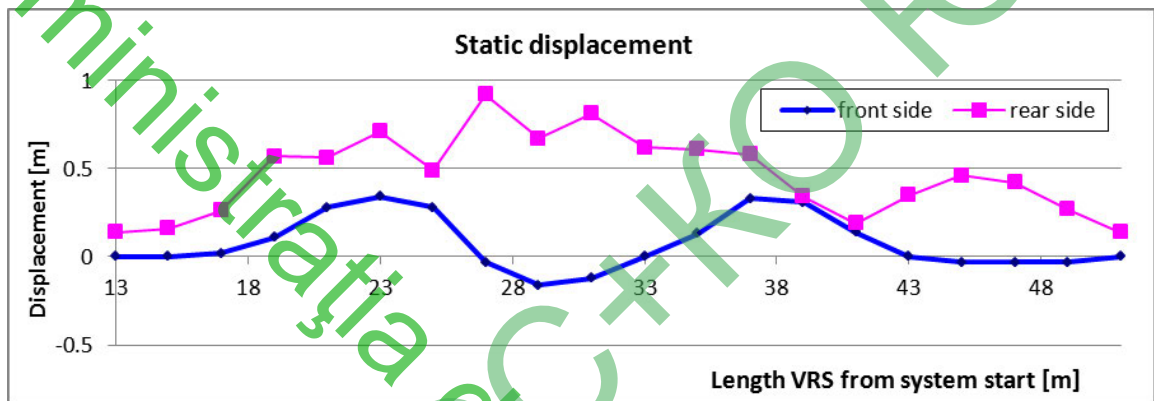
Measured every 2 m

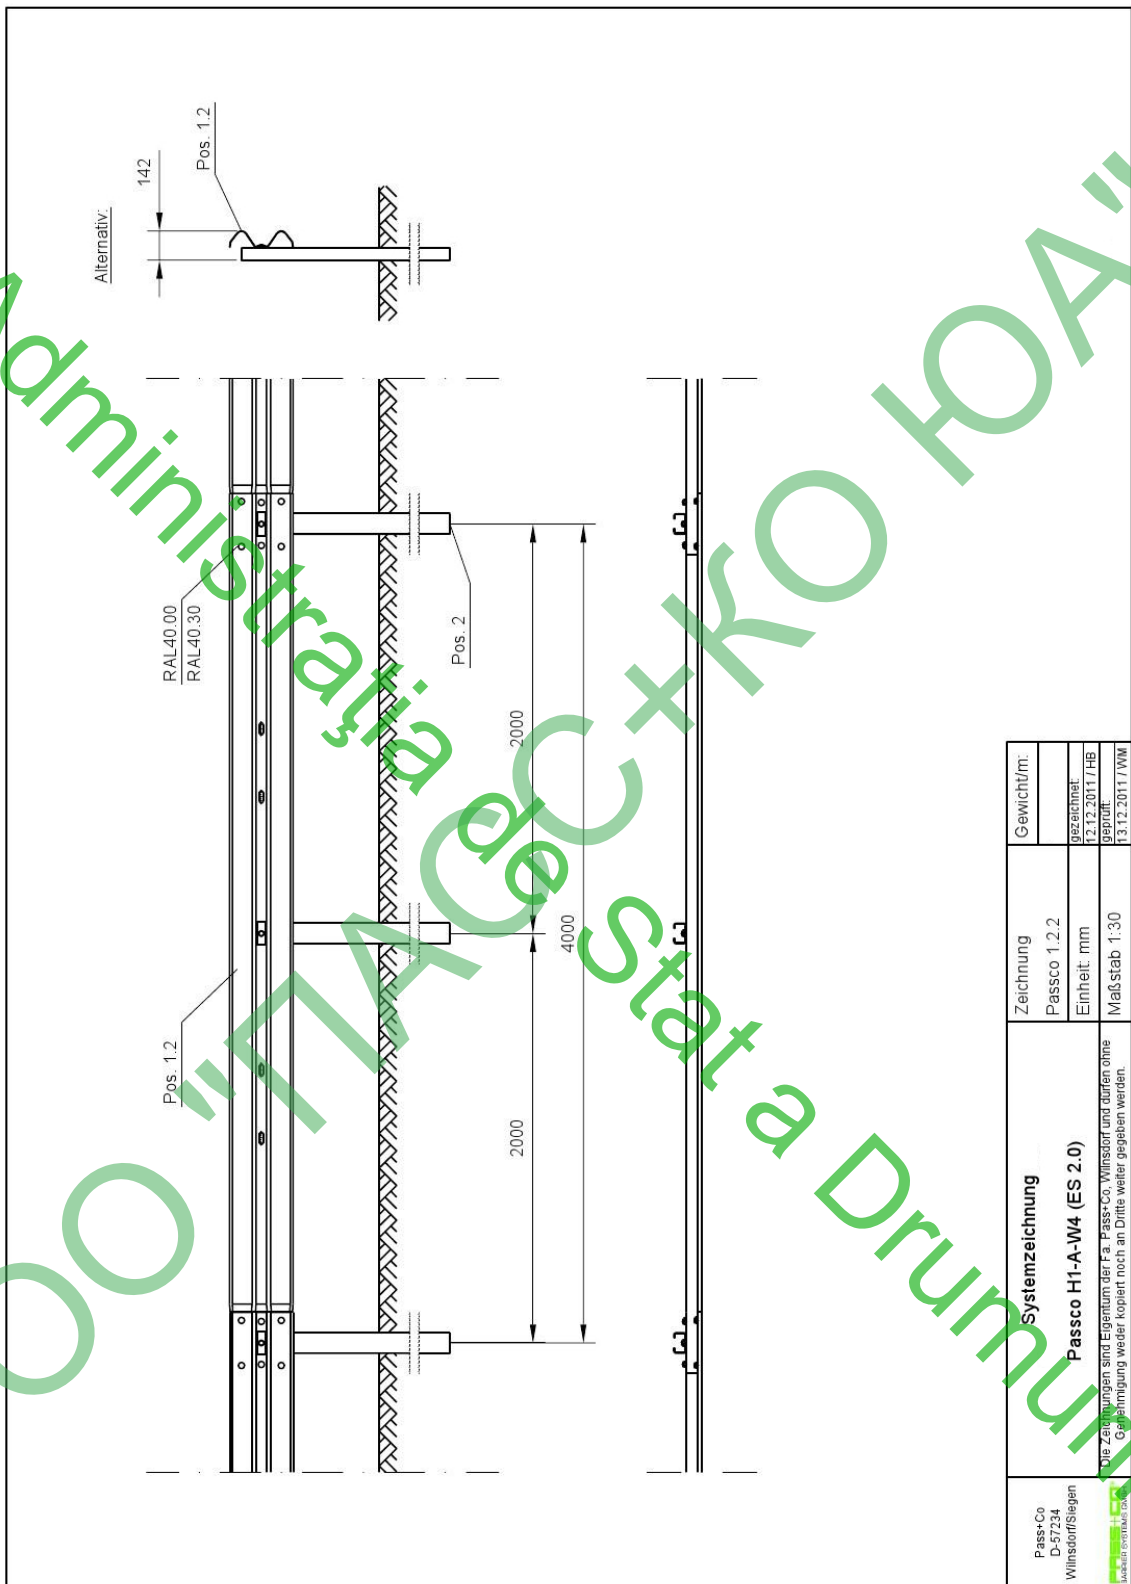
Pass-Co D-57234 Wilsdorf/Siegen <small>Marken-entwurf</small>	Systemzeichnung Passco H1-A-W4 (ES 2.0) <small>Die Zeichnungen sind Eigentum der Fa. Pass-Co, Wilsdorf und dürfen ohne Genehmigung weiter kopiert noch an Dritte weiter gegeben werden.</small>	Zeichnung	Gewicht/m:
		Passco 1.2.2	
		Einheit: mm	gezeichnet: 12.12.2011 / HB
		Maßstab 1:30	geprüft: 13.12.2011 / WM

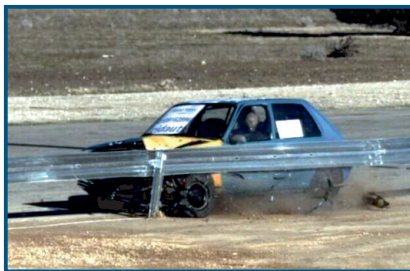
TB 11 Crash-Test

Car 900 Kg.,
100 Km/h and 20°

The "BMS4PR-H1" guardrail has successfully passed the full-scale crash-tests TB42 and TB11 according to the European standard EN 1317, meeting all acceptance criteria for **H1** containment level, **A** severity class and **W4** working width.

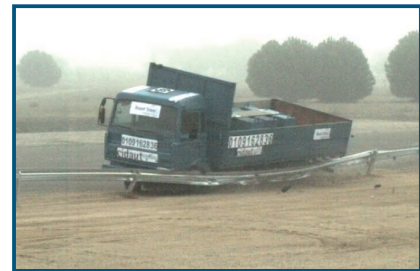
TB 42 Crash-Test

Ridig Truck 10.000 Kg.,
70 Km/h and 15°

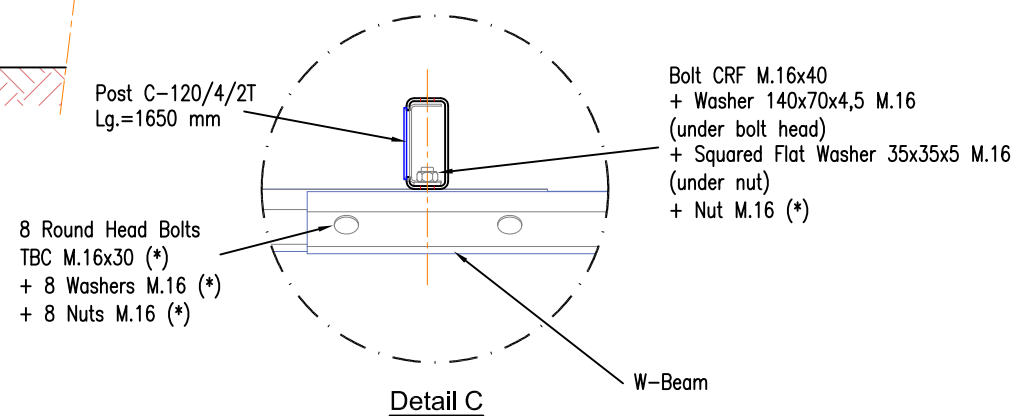
Detail C

- Bolt CRF M.16x40
- + Washer 140x70x4,5 M.16 (under bolt head)
- + Squared Flat Washer 35x35x5 M.16 (under nut)
- + Nut M.16 (*)

- 8 Round Head Bolts TBC M.16x30 (*)
- + 8 Washers M.16 (*)
- + 8 Nuts M.16 (*)

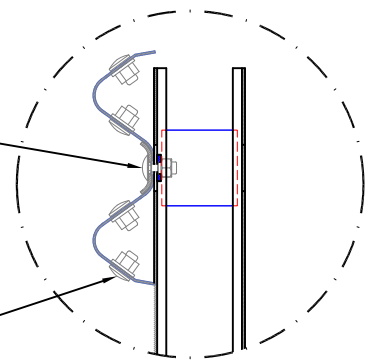
SECTION B-B'
Scale 1:10

NOTE:
W-Beams of this system are identified with the reference code number "4", just under traceability code, located in the central sine of their profile, by the middle of W-Beam.

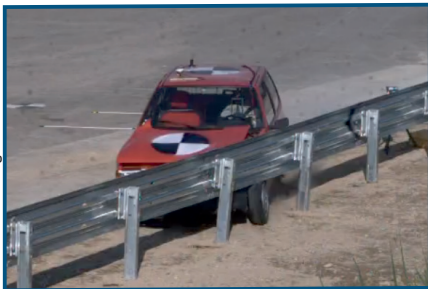
TB 11 Crash-Test
Car 900 Kg.,
at 100 Km/h and 20°

The "CPS05 H2 2.00" Single Steel Guardrail successfully passed the full scale crash-tests TB51 and TB11 according to the European standard EN 1317-2, meeting all acceptance criteria for **H2** containment level, with impact severity class **A** and working width **W4**.

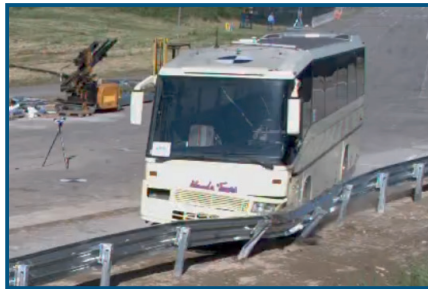
TB 51 Crash-Test
Coach 13.000 Kg.,
at 70 Km/h and 20°

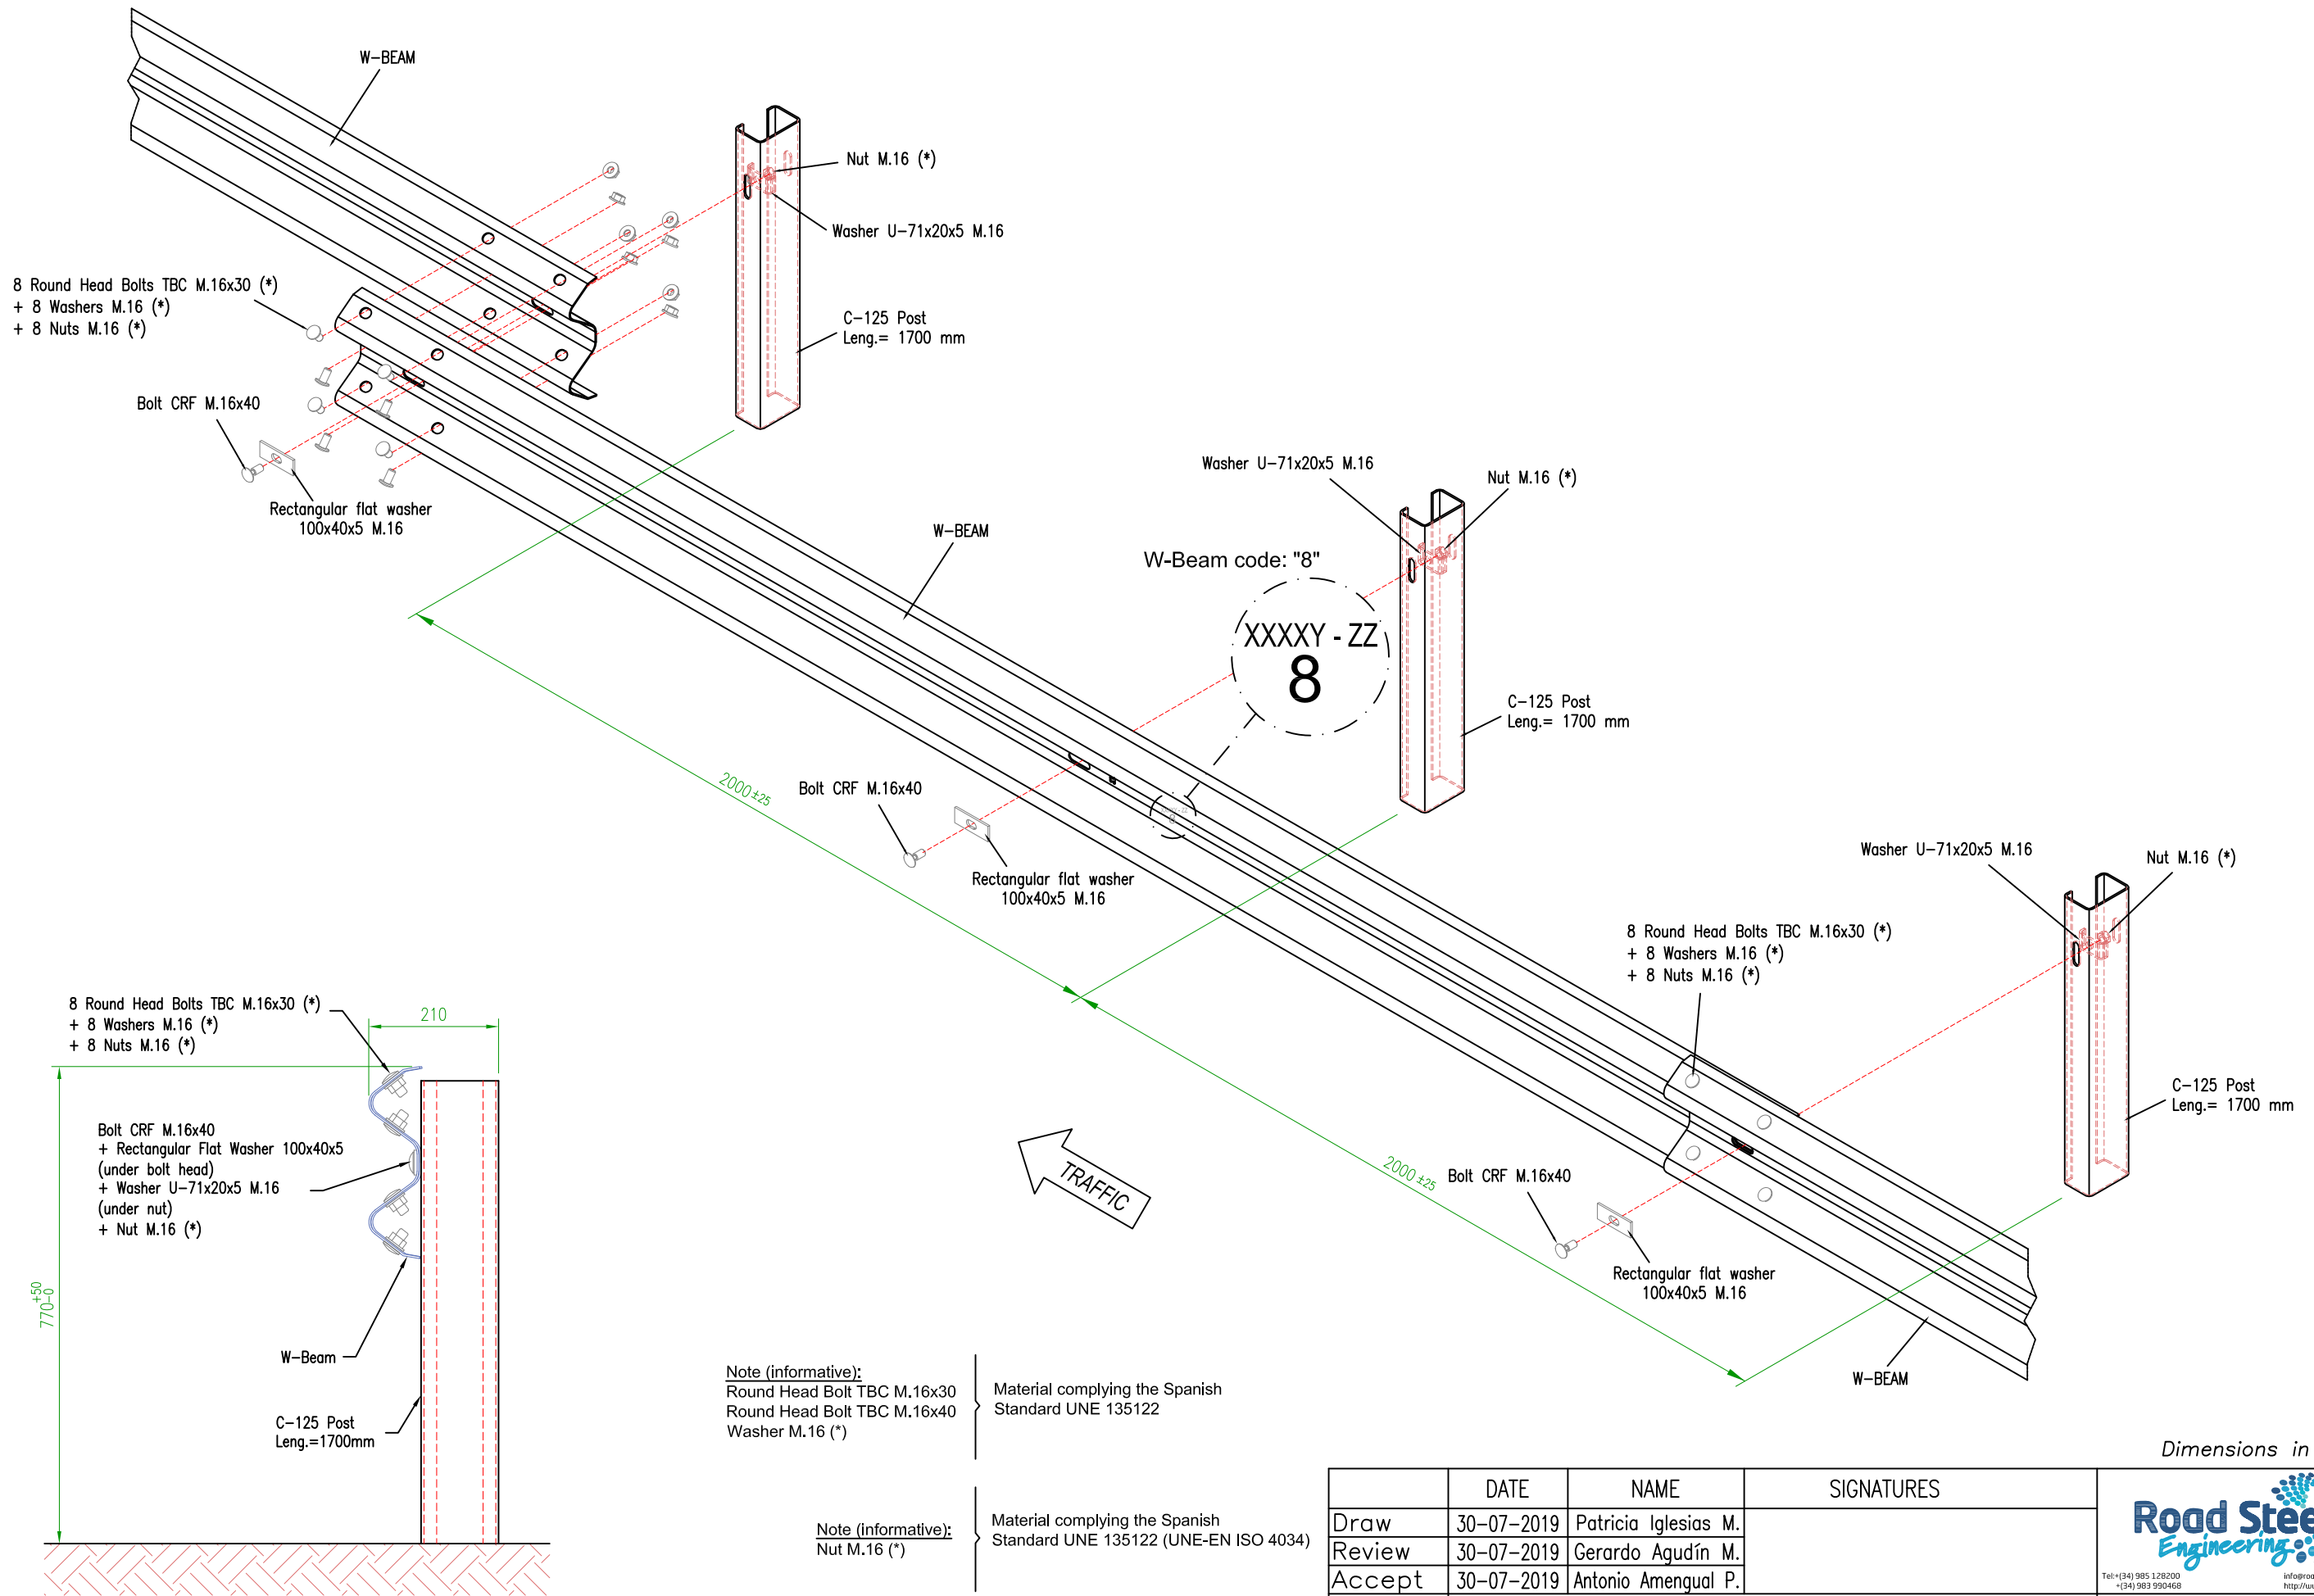
- CROSS SECTION AT POST -

NOTE:
W-Beams of this system are identified with the reference code number "8", just under traceability code, located in the sine of their profile, by the middle of W-Beam.
