NO.: ECT2019K040218-Y1 Date: Apr. 10, 2019 Page 1 of 4

Report on the submitted sample said to be:

Sample name: LED street light

**Model:** Range Leaf, sizes G1200, G1700, G2600, G3500, G3800, G5200

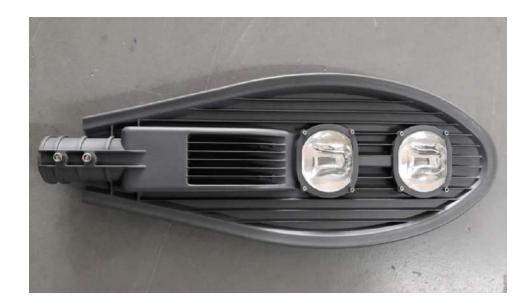
#### Photos of the sample:

Test Item	Criteria (According to the technical requirements of client)	Test Result	
IK08	No crack on the sample	After the test, there is no obvi ous appearance abnormality on the sample.	Р
