Certificate of Conformance for Freight Container Mechanical Seal Testing Seal Classification: High security seal

TEST REPORT NO.: H1207051-T01

SUBJECT: Freight containers Mechanical seals classification Testing

Name of Article: Container Seal

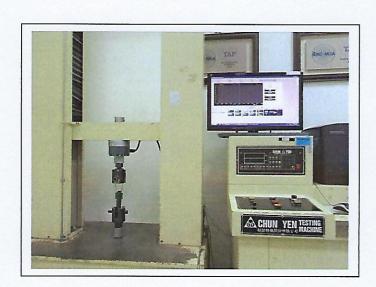
Testing Instrument: Universal Testing Machine (No.TG0103)

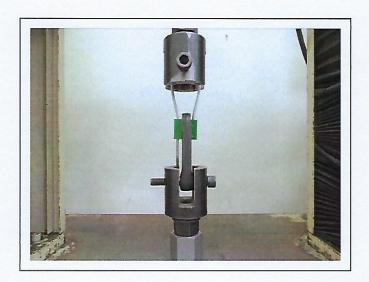
Tensile Set up

The seal was gripped in a tensile machine and a pull force applied.

Specimen No.	Requirement Load to failure	Result kN	Seal classification
000001	10.0 kN: High security seal	16.8	High security seal
000002	2.27 kN: Security seal	14.0	High security seal
000003	< 2.27 kN : Indicative seal	14.6	High security seal
000004		15.4	High security seal
000005		16.0	High security seal
