Service Manual

KONICA MINOLTA DRYPRO SIGMA Laser Imaging System

Document No.: 9G9002

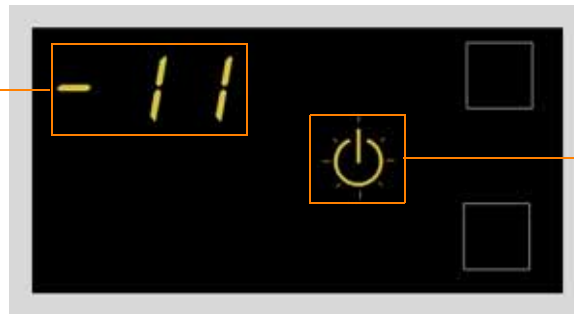
A countdown to zero (0) indicates how soon the laser imager will be ready to print

The power symbol is yellow and flashing while the laser imager warms up
