## 1. General Aspects

## 2. Control cabinet(+ER)

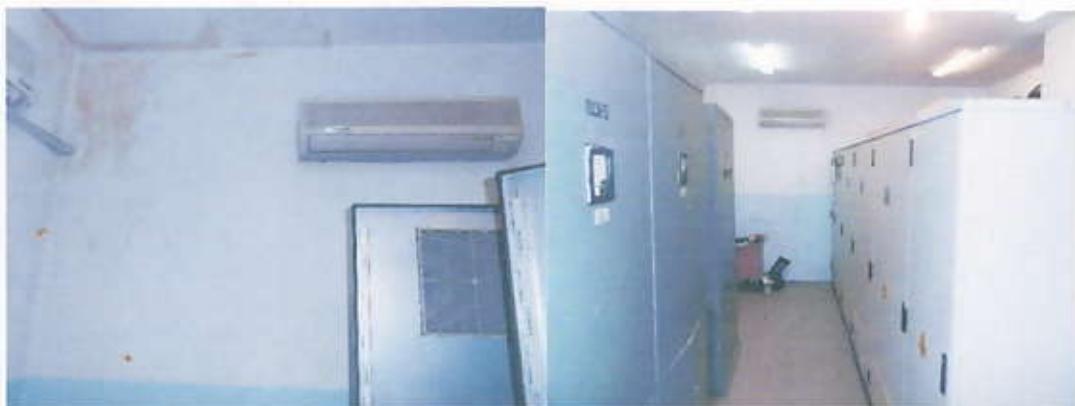
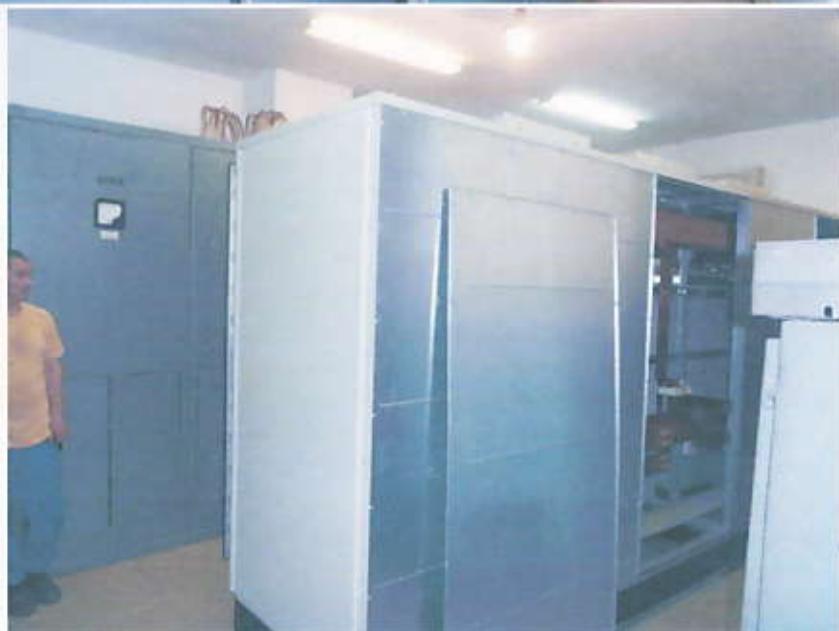
Unitrol is mounted in the clean room with mean temperature 23 C. Air conditioning is present. There is no chemical impact against the appliance. Access to rear and the front of the appliance is possible.

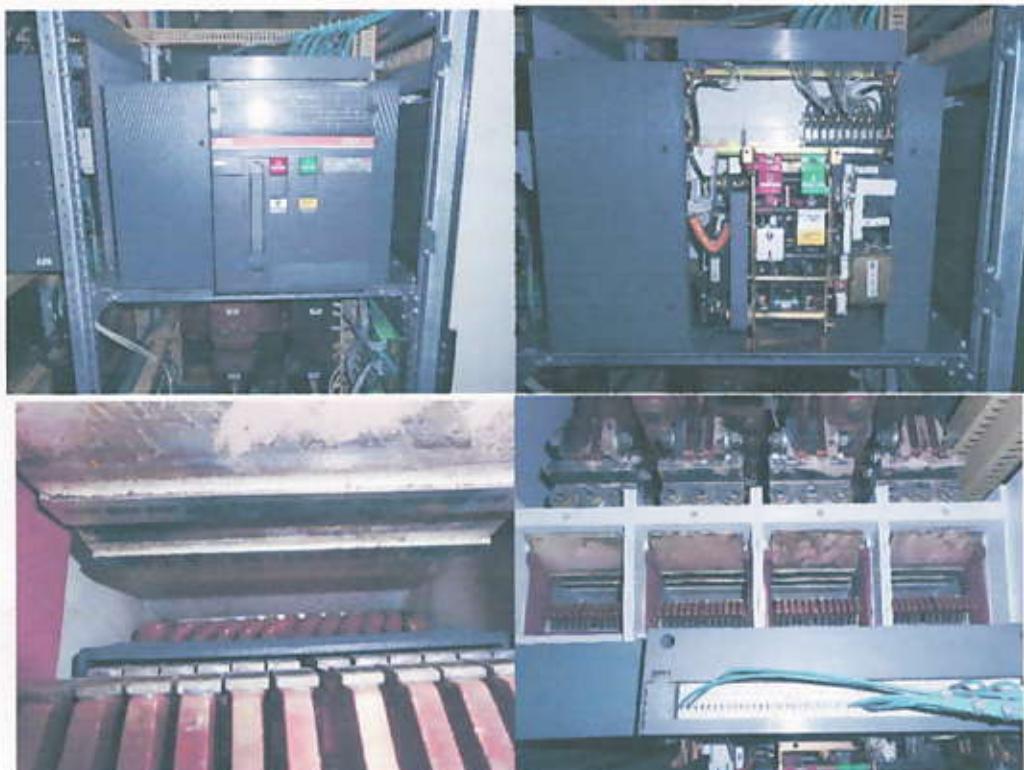
The old field circuit breaker will be used. The FCB is in good condition, contacts are clean, spring mechanism is in order and is regularly replaced by the personnel.

Snubber circuits capacitors and resistors were checked – no remarks. ( $C \approx 31 \mu F$   $R = 1145 \Omega m$ ), Shaft filter capacitors were checked – no remarks  $C \approx 2 \mu F$ , FCB generally is in good condition. Main contacts are clean without traces of the arc. New terminals for the input of aux. 380 VAC and 230 VDC will be required.

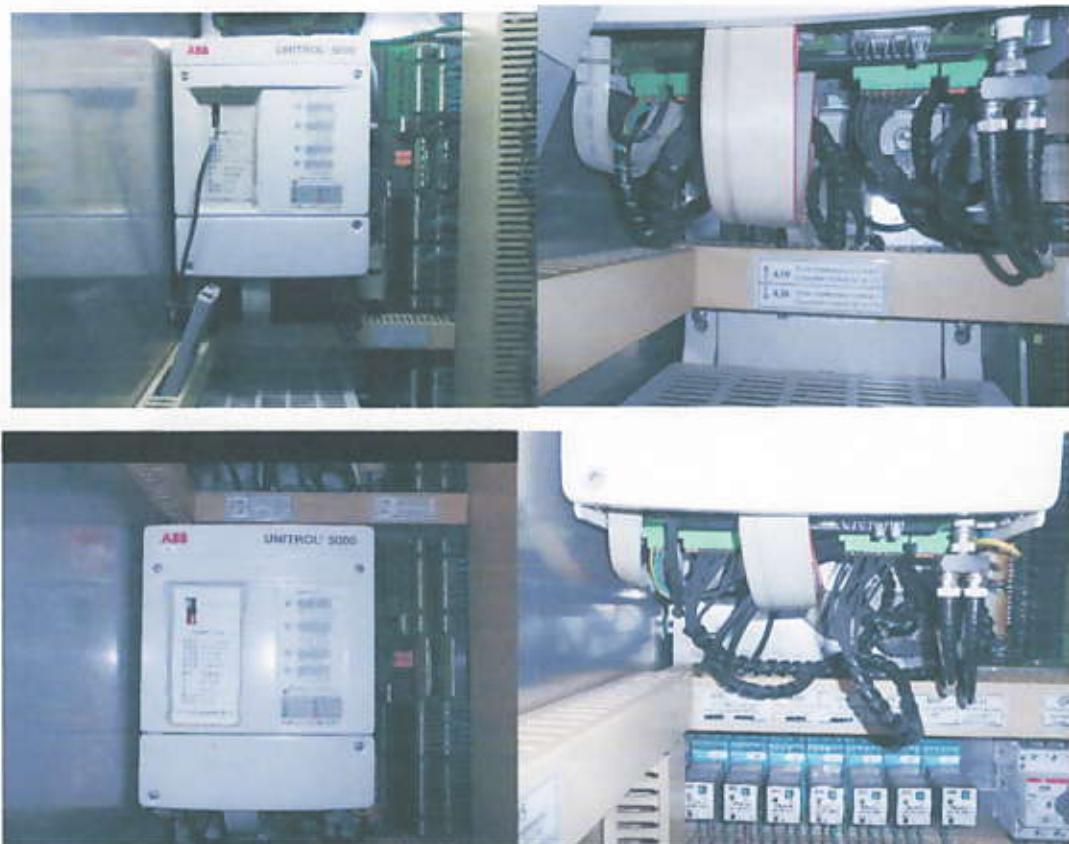
Picture of the UNITROL rack including the cables to the cabinet.

The instruments on the door are:

- Ammeter;
- Voltmeter;

Number of fans installed: 1 piece;

The general status of the door is good. The ECT is required.

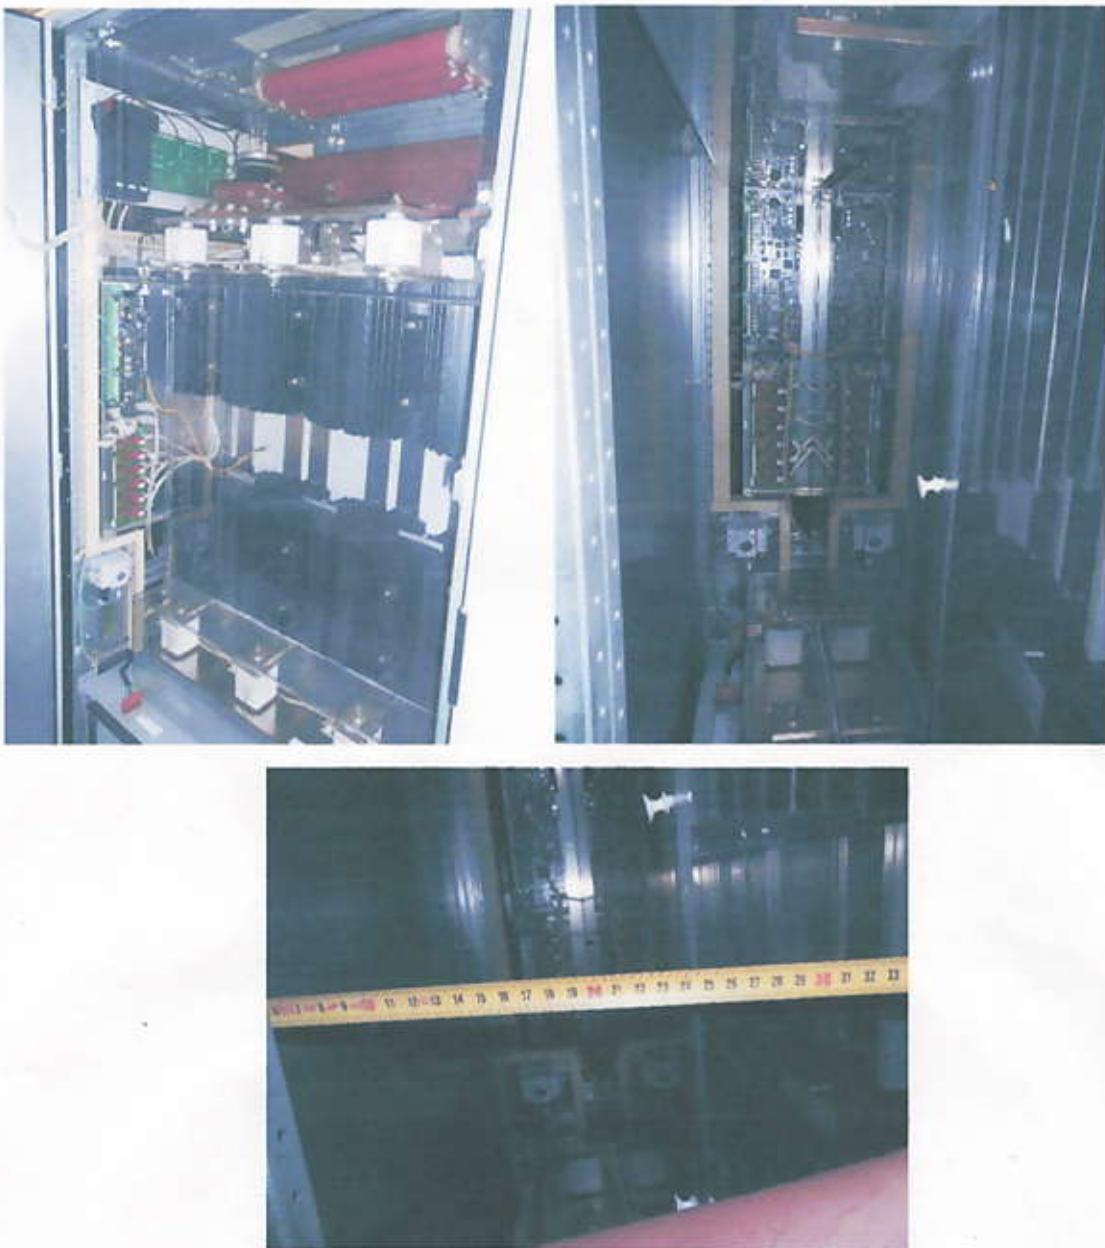
The unit has three identical cabinets. There is no heavy dust inside the condition is good.

Plexiglas position is not preventing the new plates to be installed in the cabinets.

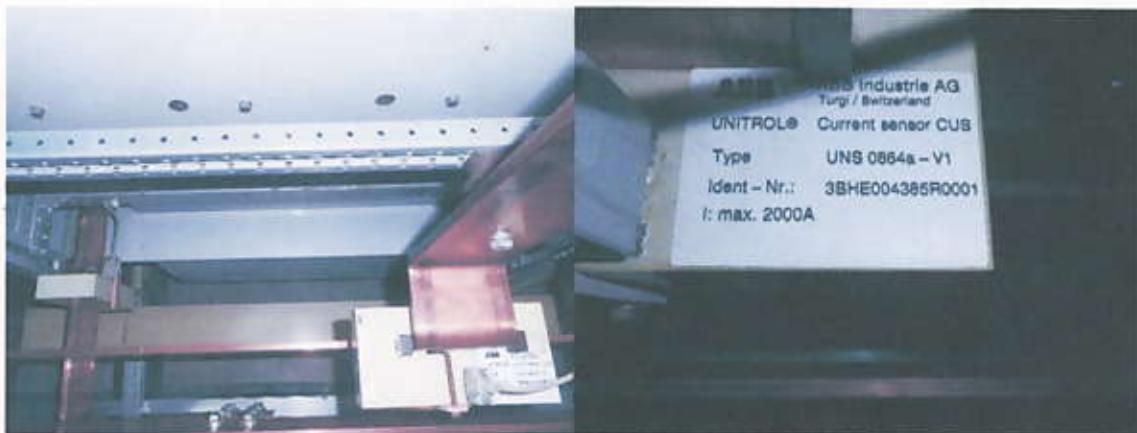
Picture of existing current sensors or other equipment installed on the bus bars

It was evaluated that there is a possibility of installing the new CTs at AC side.

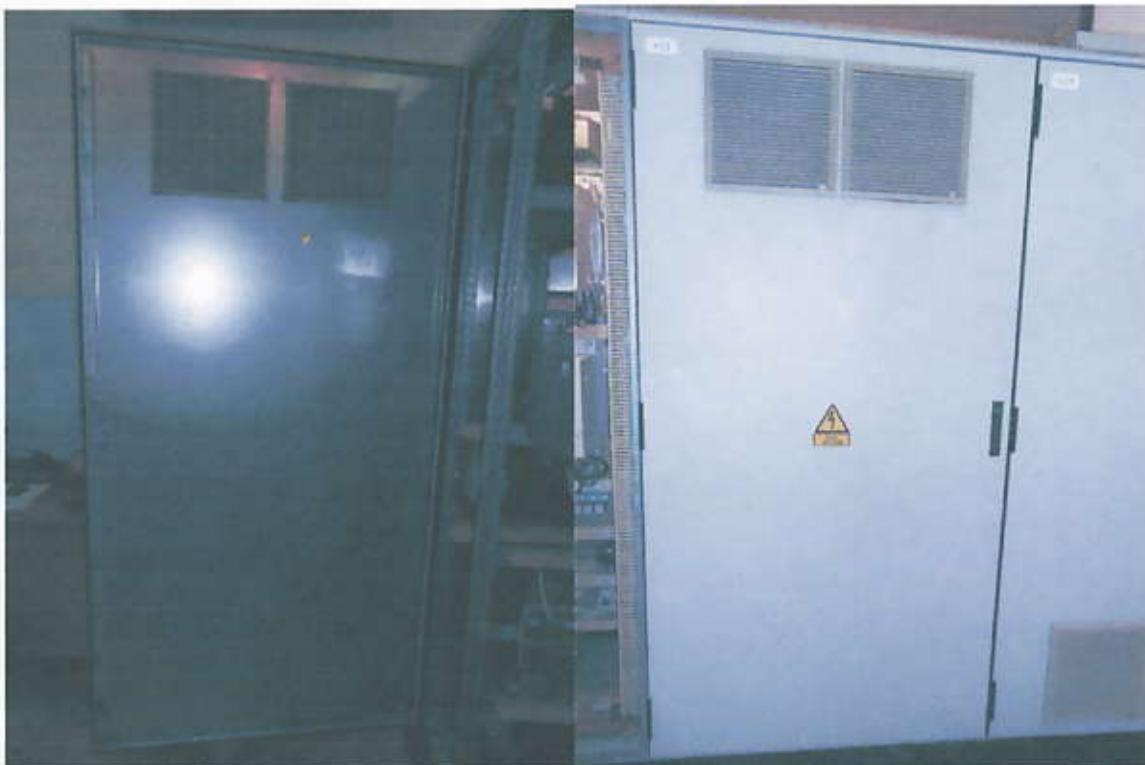
Cabinet door pictures.

The door is without the instruments and fans. The general condition of the door is good.

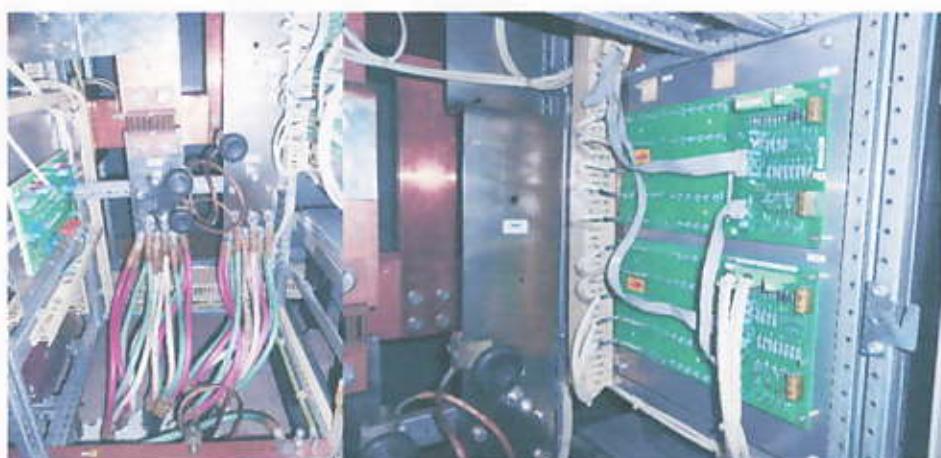
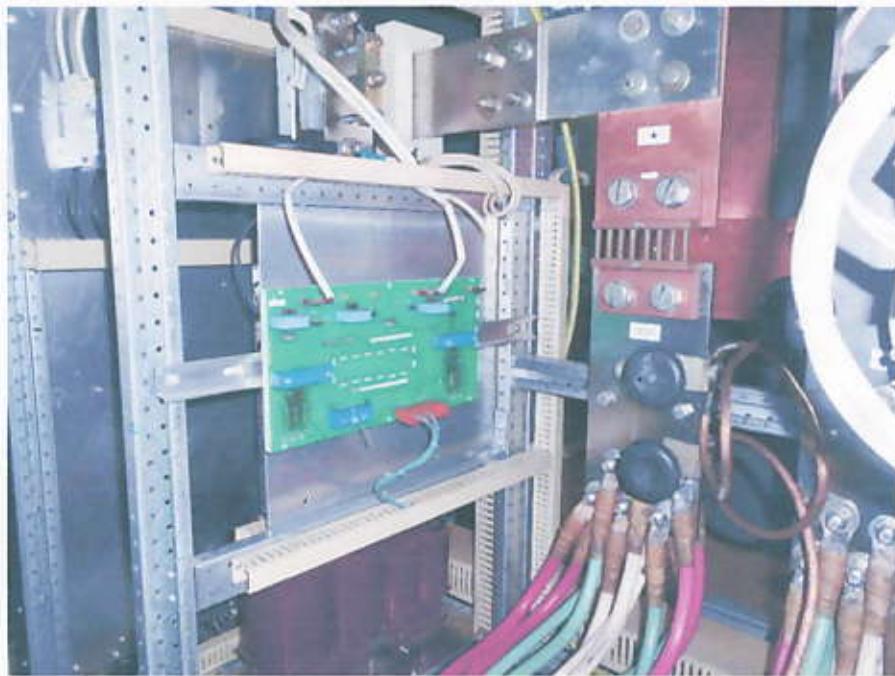
Picture of the converter including the cables.

The overall condition of cubicle is good. The cubicle is clean without heavy dust.

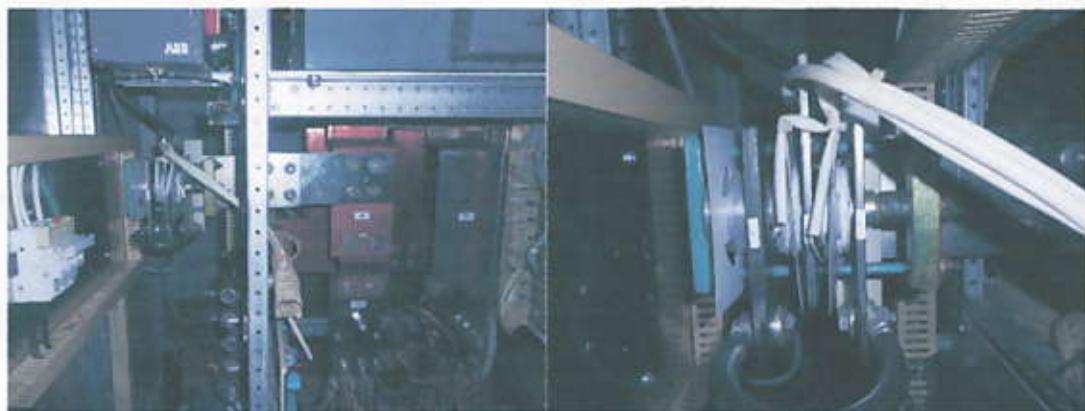
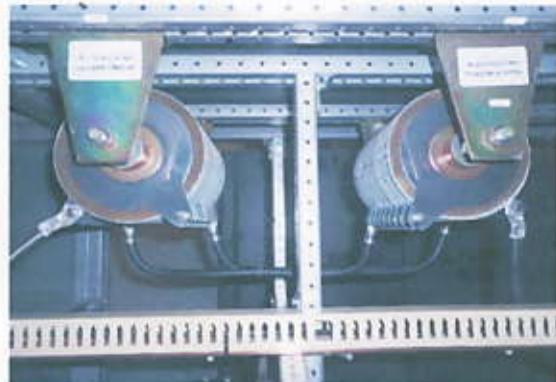
Picture of the crowbar

ID plate HIEE205010R0001; UNS3020A-Z V1

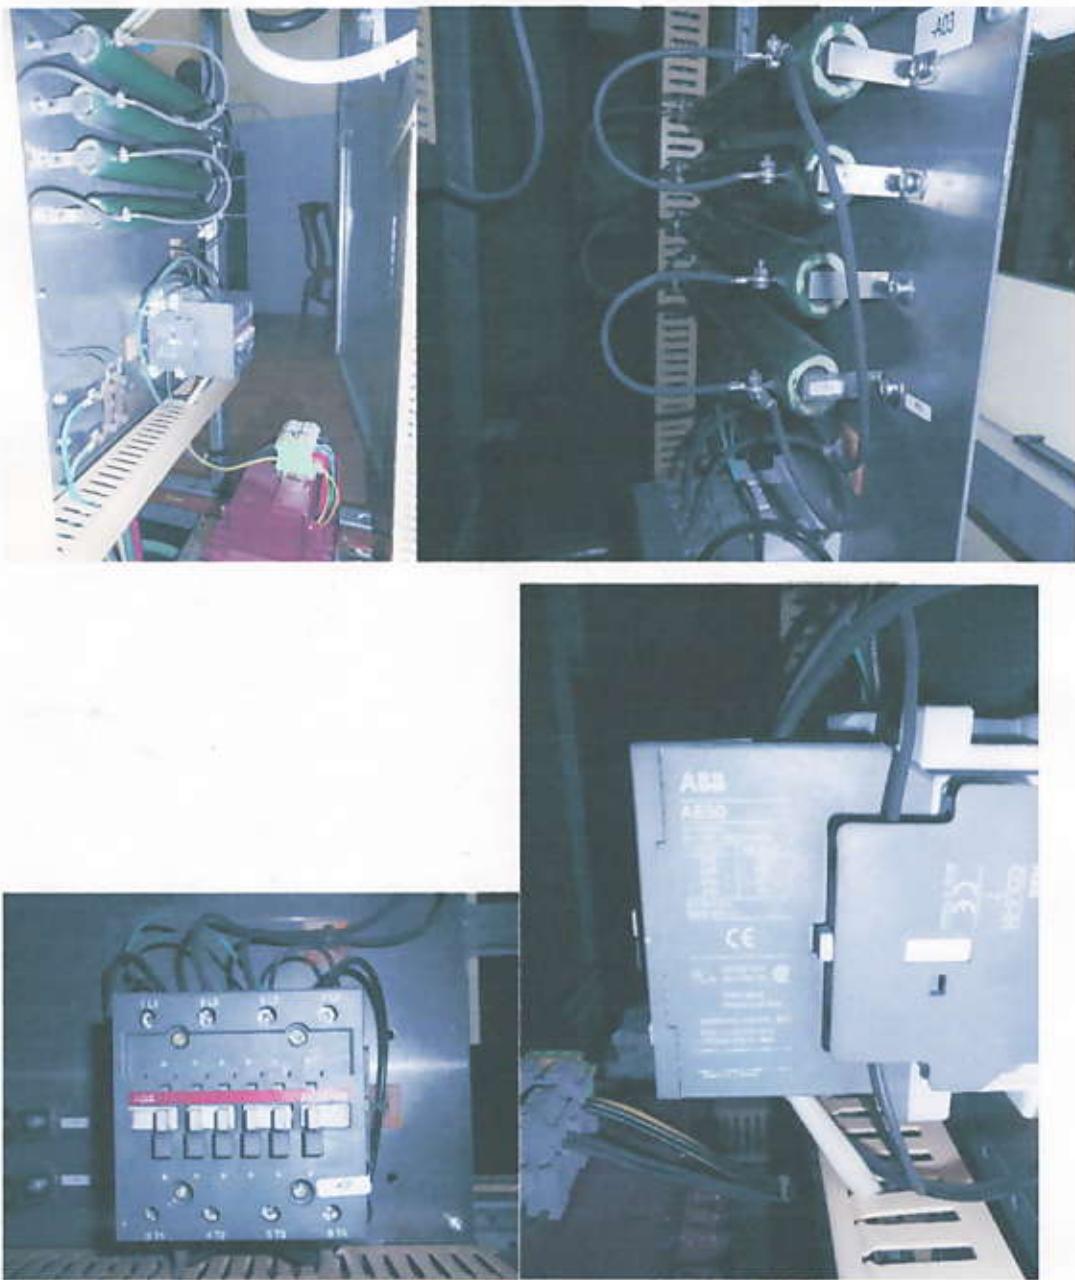
## Field flashing device

Types and level of supply voltages in the system:

- Battery; 236V;
- Aux.supply: 386 V;
- Voltage from exc.transformer: 585 V;
- Trafos: T15 - 585/230, t05 – 580/170-230 V
