TEST REPORT

NO.: ECT2019K040218-Y1

Sample name: LED street light

Model: Range Leaf,sizes G1200, G1700, G2600, G3500, G3800, G5200

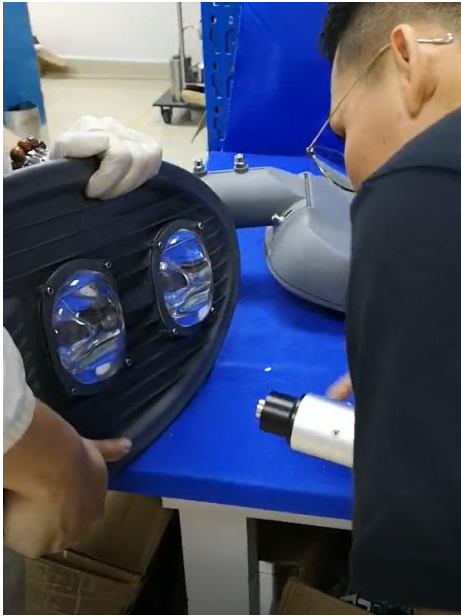
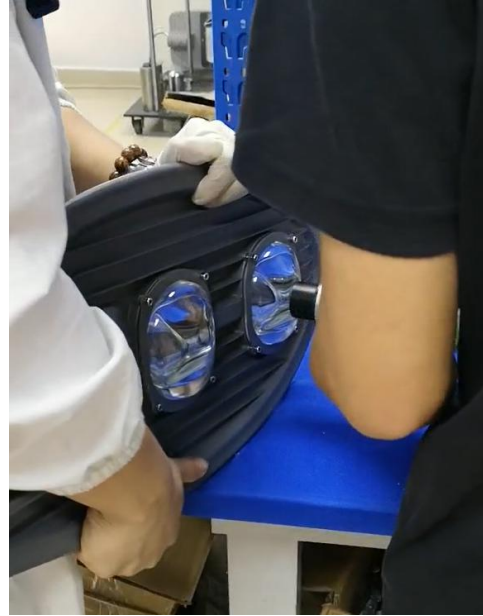
Photos of the Testing:

- 1) Ambient temperature and relative humidity: 23.5°C, 58% RH
- 2) Test condition:
 - a) The sample is placed on the ground, The energy of impact test specimens for 1J;
 - b) The impact point is uniformly distributed on the sample
 - c) Check the samples after test
