TEST REPORT

NO.: ECT2019K040218-Y1

Sample name: LED street light

Model: Range Leaf, sizes G1200, G1700, G2600, G3500, G3800, G5200

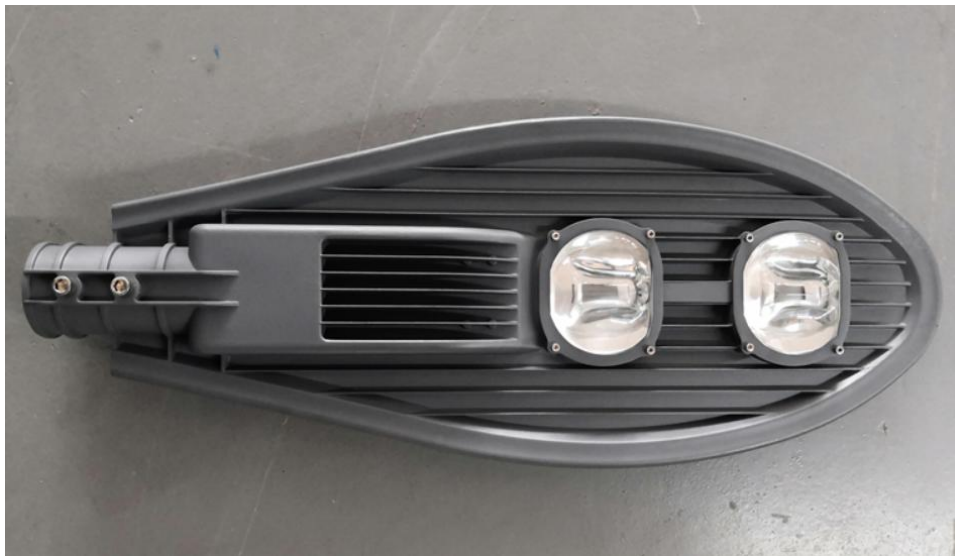
Photos of the sample:

Test Item	Criteria (According to the technical requirements of client)	Test Result	
IK08	No crack on the sample	After the test, there is no obvious appearance abnormality on the sample.	P

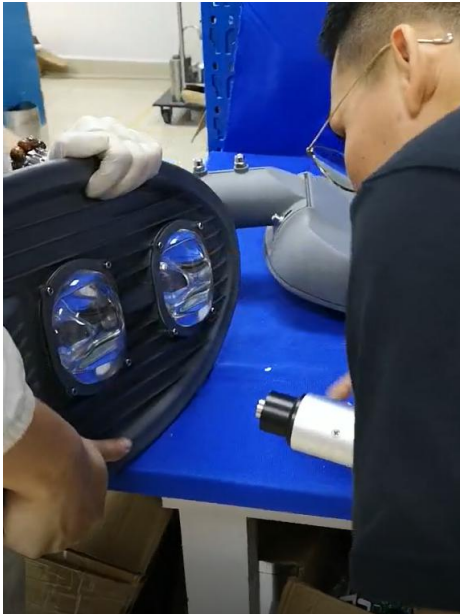
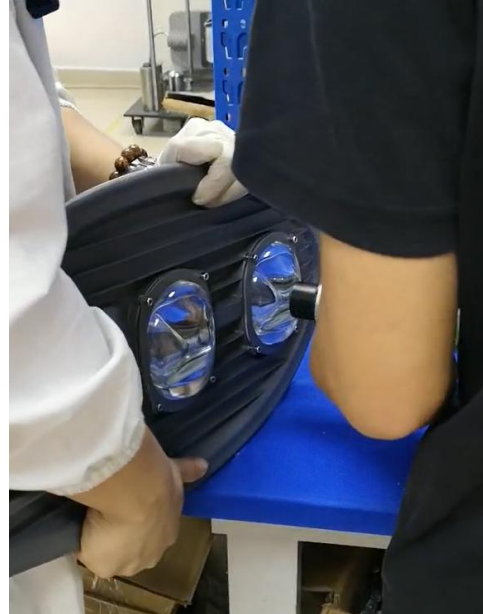
Photos of the Testing:

- 1) Ambient temperature and relative humidity: 23.5°C, 58% RH
- 2) Test condition:
 - a) The sample is placed on the ground, The energy of impact test specimens for 1J;
 - b) The impact point is uniformly distributed on the sample
 - c) Check the samples after test
