## TEST REPORT

<b>Laboratory</b>	<b>ROOF AND FAÇADES ELEMENTS – CAR</b>	<b>O/Reference</b>	DE-CAR-0169 (DE651XP322) CAR-19-183 (CAR 18247) Page 1 of 5
-------------------	--	--------------------	---

On request of Profilsa Plastik Sanayi ve Ticaret A.S. represented by Ali Gürbag, BBRI carried out some tests in order to measure the tensile strength  $Q$ , the shear strength  $T$  and the elasticity constant  $c$  according to EN 14024 (2005). The results of these tests are given in the present report.

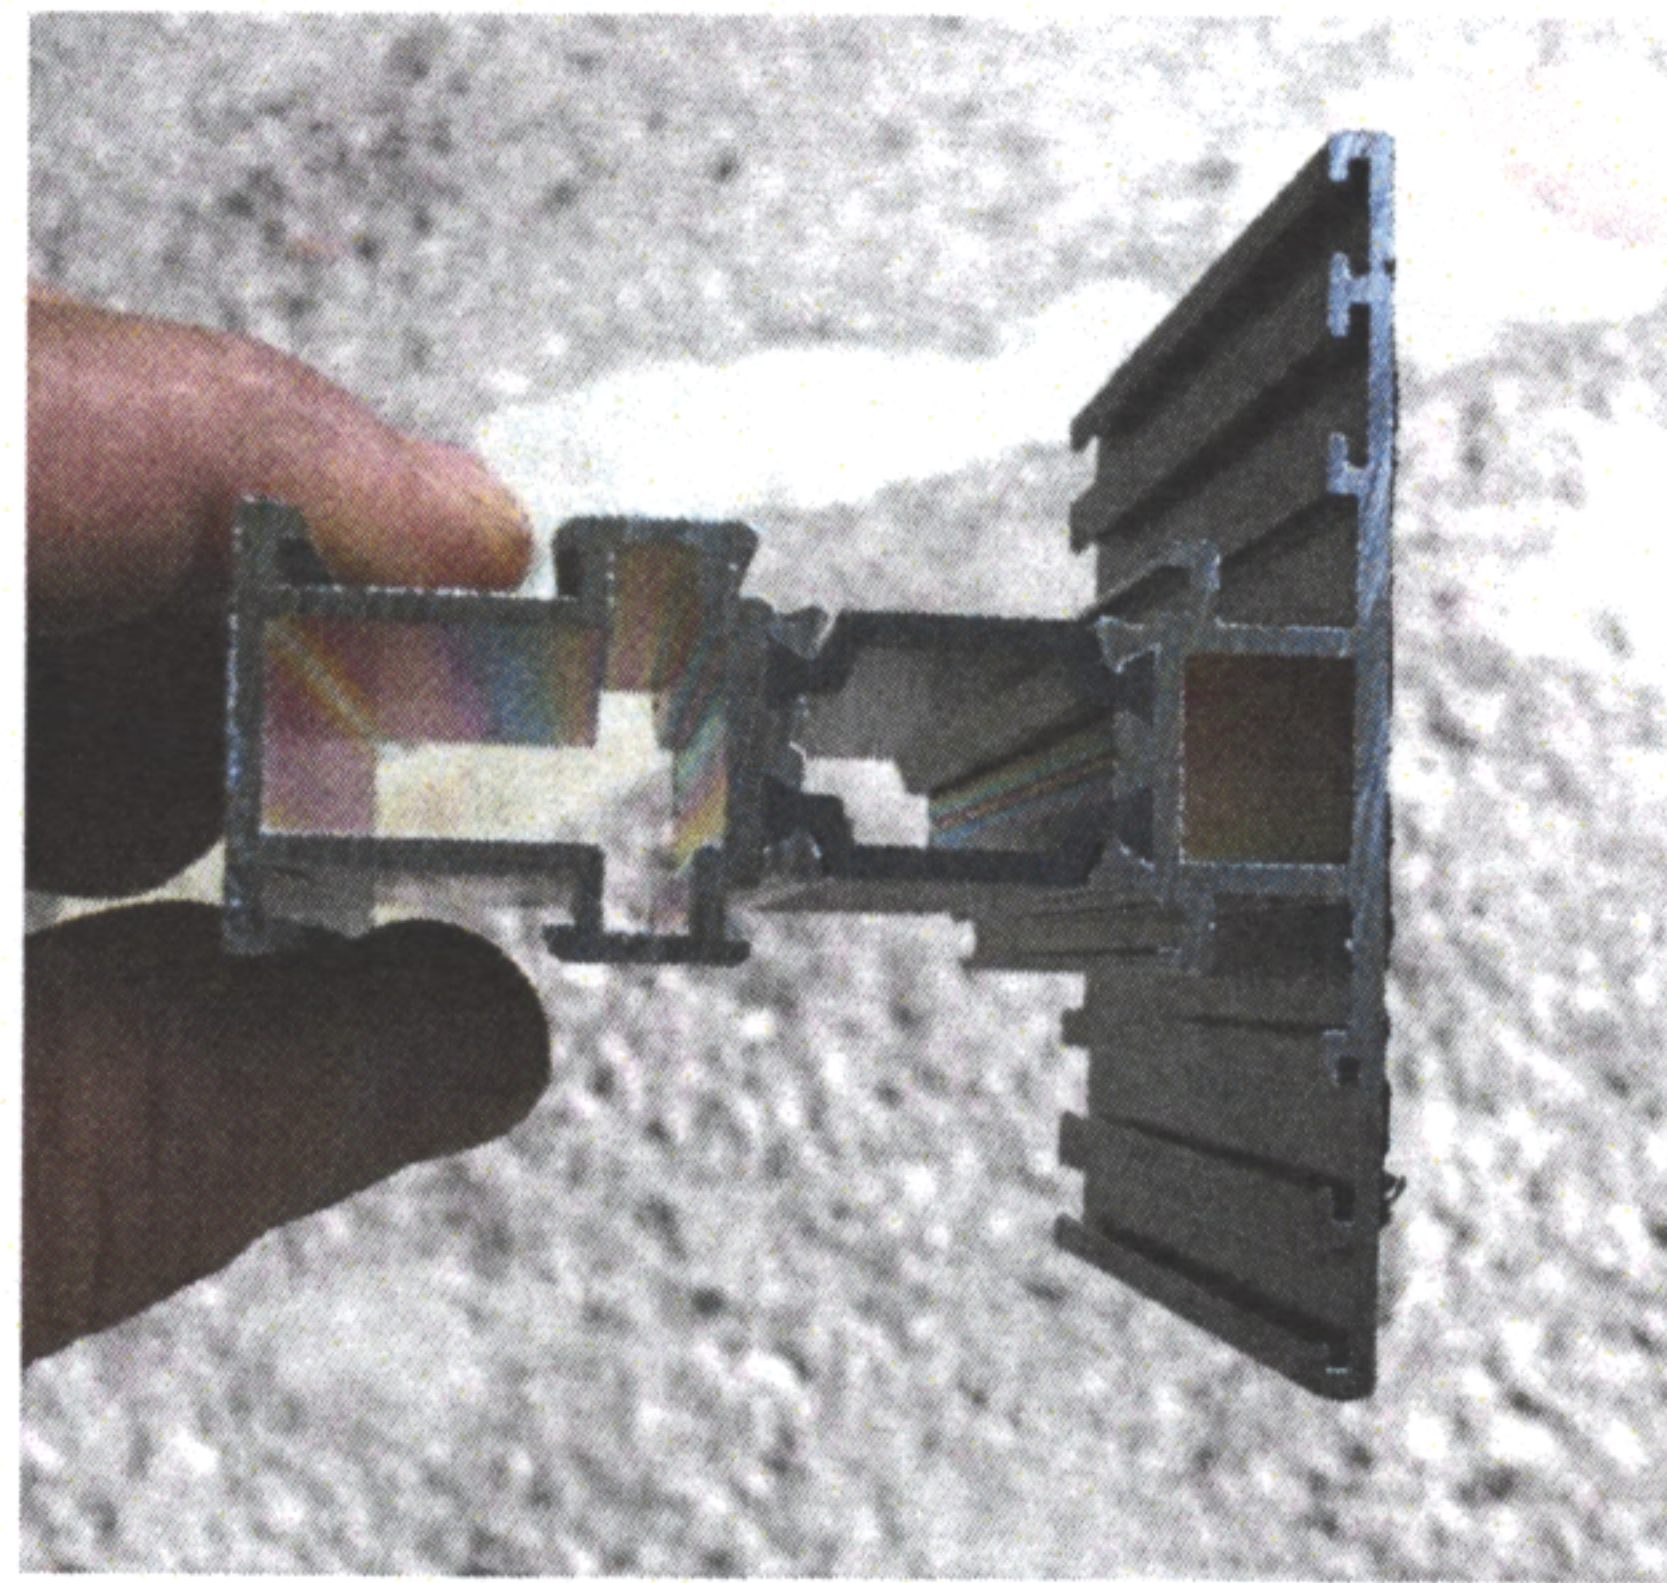
*Figure 1: Cross view of the sample*

The schematic representation of the samples is shown in the different figures below.

- Profile number: Not communicated
  - Thermal break: PA 24002, material PA66GF25, 2mm (thickness of cavities wall)
  - Surfacing: varnished after strutting
