of a type of pneumatic tyre for motor vehicles pursuant to Regulation number 30.

Approval number: E4-30R-0269526

1. Manufacturer's name or trade mark(s) : GRIPMAX  
on the tyre type
2. Tyre type designation by the manufacturer : STATURE H/T
3. Manufacturer's name and address : SHANDONG JINYU INDUSTRIAL CO., LTD.  
Guangrao ETDZ, Dongying City,  
Shandong Province, P.R. China
4. If applicable, name and address of the manufacturer's representative : not applicable
5. Summarised description
  - 5.1. Tyre size designation : 235/55R18
  - 5.2. Category of use : normal/snow/temporary use <sup>(1)</sup>
  - 5.3. Structure : ~~diagonal/bias belted~~/radial
  - 5.4. Speed category symbol : V

## TEST REPORT

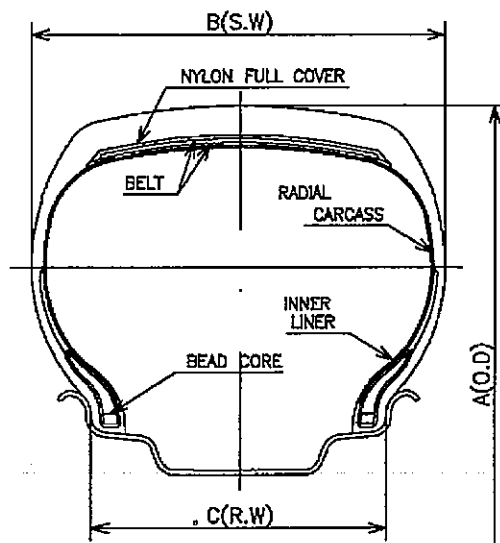
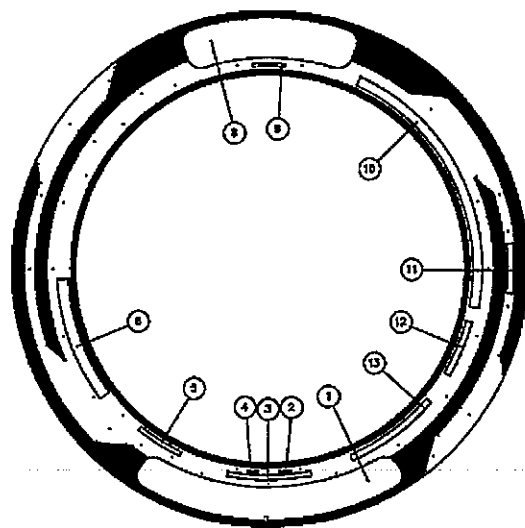
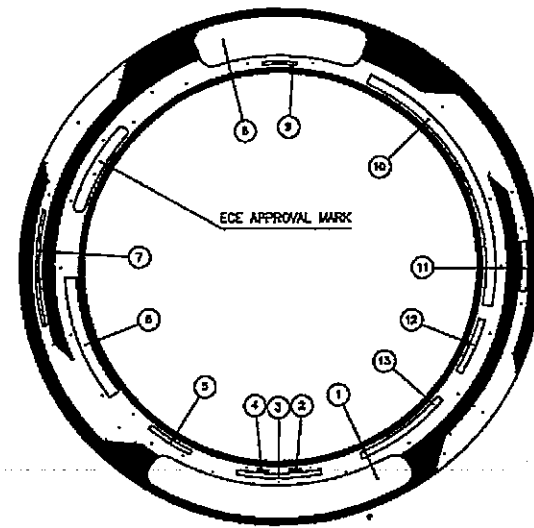
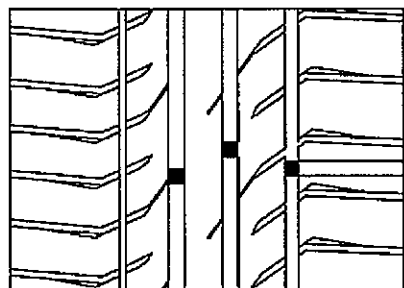
STATURE H/T

TREADWEAR INDICATOR

| 1 | STATURE H/T | 9 | MADE IN CHINA |
| 2 | KEJC | 10 | SAFETY WARNING |
| 3 | RADIAL TUBELESS | 11 | INSIDE(OUTSIDE) |
| 4 | RIM: 7 1/2J | 12 | MAX. LOAD 800 KG(1764 LBS)<br>MAX.PRESS 300KPA(44PSI) |
| 5 | DOT KEJC DXP XXXX (DATE CODE) | 13 | SIDEWALL PLIES: 2 POLYESTER<br>TREAD PLIES: 2POLYESTER+2STEEL+1NYLON |
| 6 | 235/55R18 100V | | |

| TIRE SIZE | A(mm) | B(mm) | C(INCH) | LOAD INDEX<br>SPEED CODE | REMARK |
| 235/55R18 | 715 | 245 | 7.5 | 100 V | |
