# Laboratory Test report

## Tightness test

Subject : IZYLUM 4 - 120 LH351C - 2x Philips FP 150W - Nema - CL II (N°125)

Test number : D200469

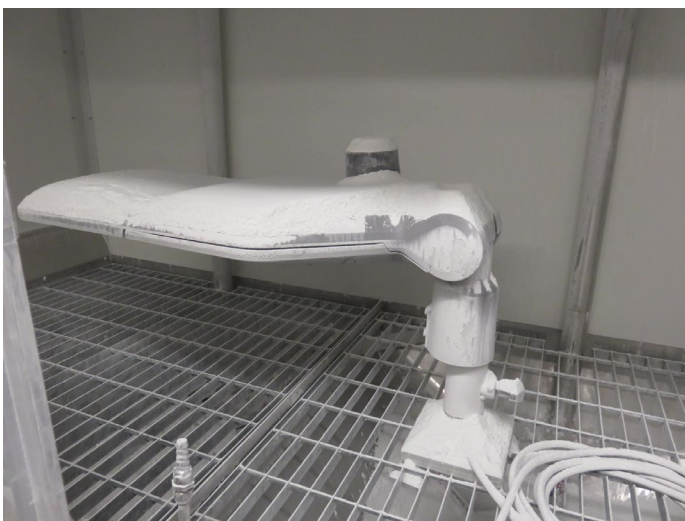
IMG\_6209

Test succeeded: no dust ingress in the optical and auxiliary parts.

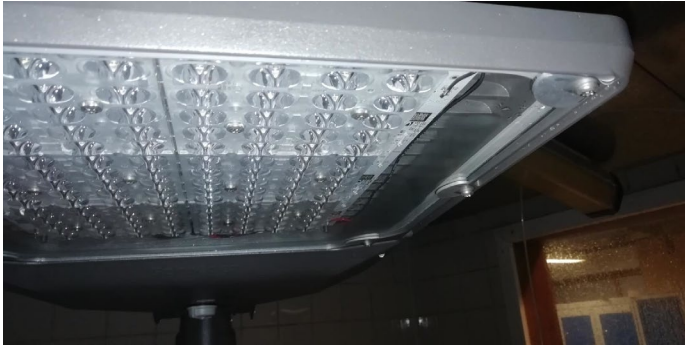
IMG\_20200408\_111814

Test succeeded: no water ingress in the optical and auxiliary parts.

Condensation in the optical part. (see picture)
