TEST REPORT

NO.: ECT2019K040217-Y1

Sample name: LED street light

Model: FUSION and FUSION-2, sizes SS, S, M, and L

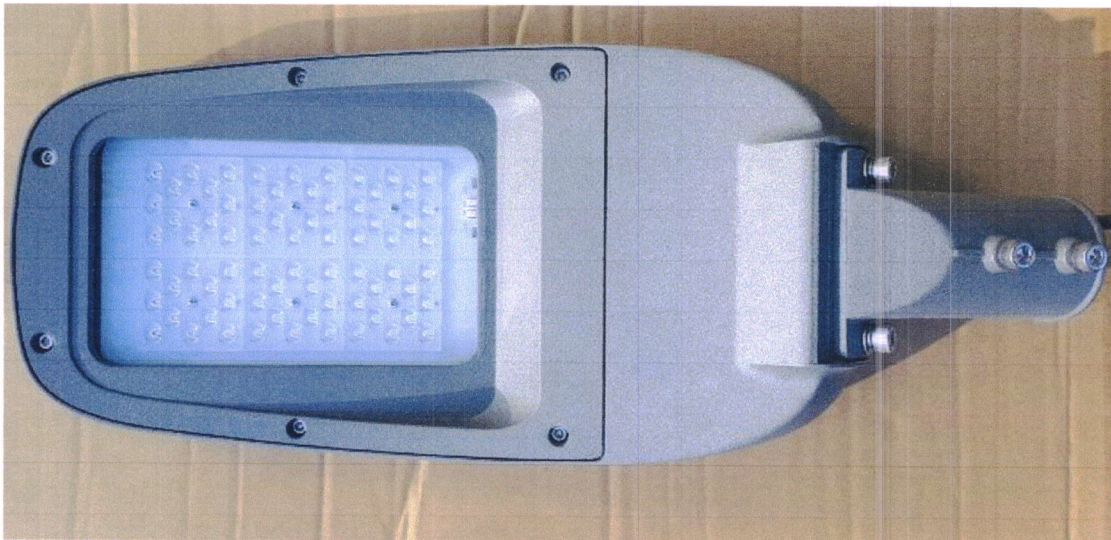
Photos of the sample:

Test Item	Criteria (According to the technical requirements of client)	Test Result	
IK09	No crack on the sample	After the test, there is no obvious appearance abnormality on the sample.	P
