# **TEST REPORT**

**TEST REPORT NUMBER : CGZ3170720-02355-L**

| <b>Sample Description</b> ..... | Autoclave bags |
| <b>Test Item*</b> ..... | High Temperature test |

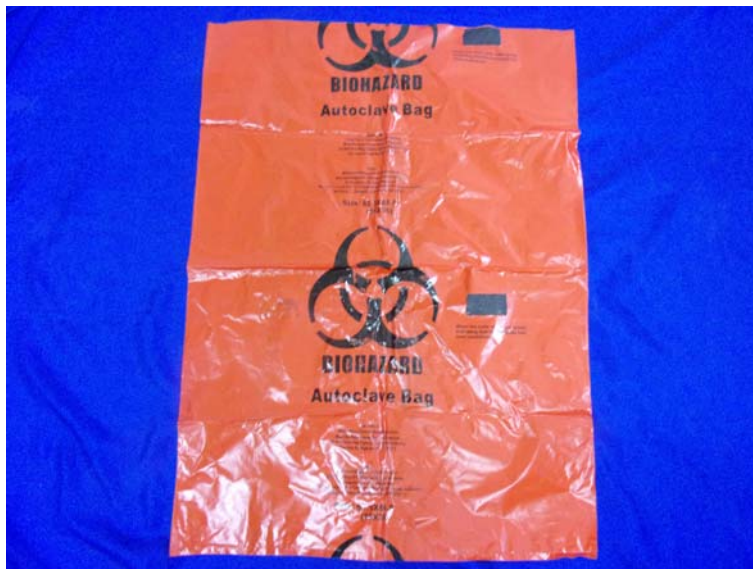
Figure 3 ( After test - 1)

| No. | Test Sample Name | Test Item | Test Results | Verdict |
|---|---|---|---|---|
| 1. | Autoclave bags<br>AB-001 | High Temperature test:<br>135 °C , 30 min. | After test,<br>the black font and pattern on<br>autoclave bags surface has<br>some fade,<br>and the high temperature<br>discoloration became dark<br>brown.<br><br>The inside of the autoclave<br>bags is slightly glued together;<br><br>no visible deformation,<br>blistering, melting. | --- |
