# TEST REPORT

NO.: ECT2019K040217-Y1

**Sample name:** LED street light

**Model:** FUSION and FUSION-2, sizes SS, S, M, and L

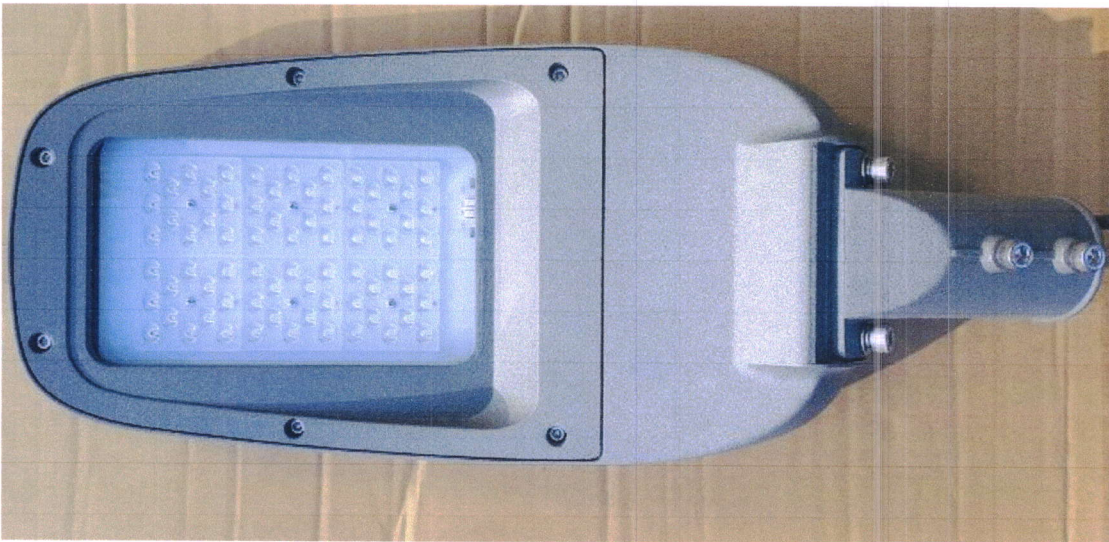
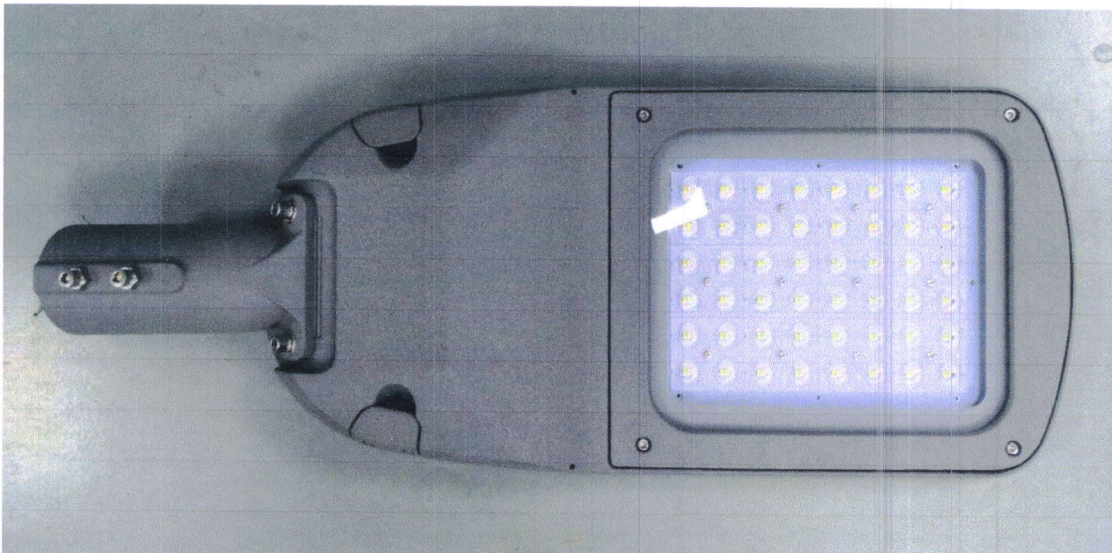
## Photos of the sample:

Test Item	Criteria (According to the technical requirements of client)	Test Result
IK09	No crack on the sample	After the test, there is no obvious appearance abnormality on the sample. P

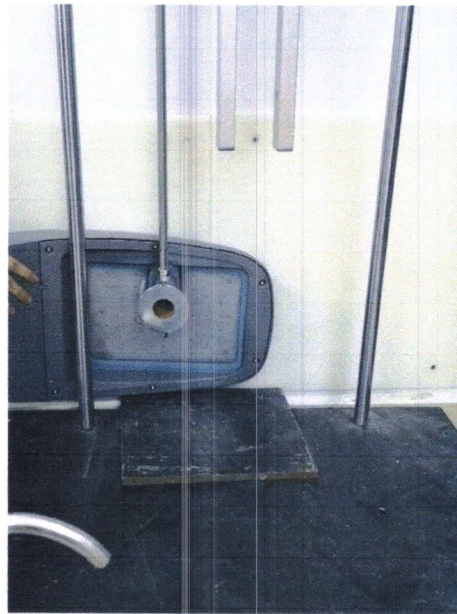
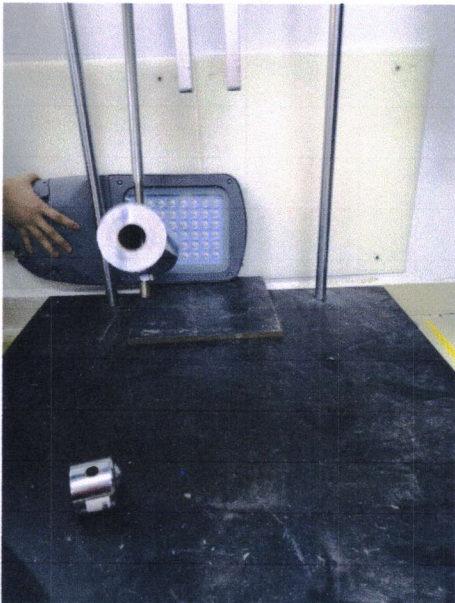
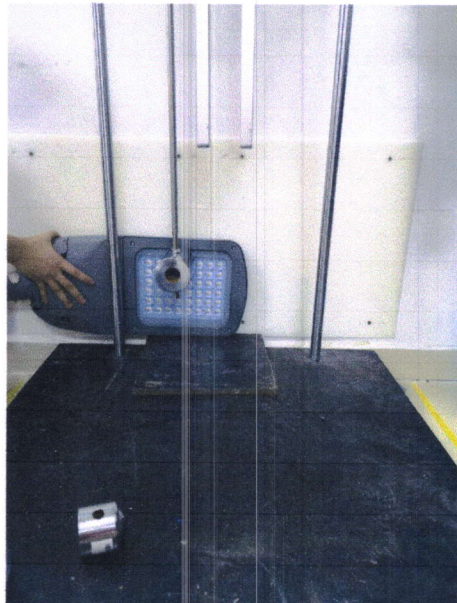
## Photos of the Testing:

- 1) Ambient temperature and relative humidity: 23.5°C, 58% RH
- 2) Test condition:
  - a) Place the sample lean on the wall, drop the pendulum bob which weight is 5 kg to impact the sample from a height of 200 mm, the impact energy is 10J.
  - b) The impact point is uniformly distributed on the sample
  - c) Check the samples after test
